## The Condition of the Aberfeldy Footbridge after 20 Years in Service

# THE CONDITION OF THE ABERFELDY FOOTBRIDGE AFTER 20 YEARS OF SERVICE

Dr Tim Stratford  
School of Engineering, The University of Edinburgh,  
The King's Buildings, Edinburgh, EH9 3JL, Scotland  
Email: [Tim.Stratford@ed.ac.uk](mailto:Tim.Stratford@ed.ac.uk)

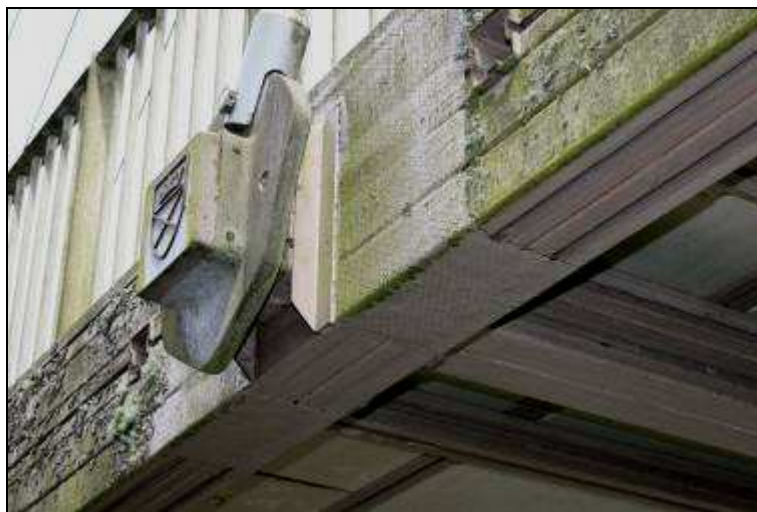
Figure 6. CFRP strengthening retrofitted around a primary transverse beam (June 2008)

The bridge was strengthened during 1997 by bonding and rivetting GFRP plates onto the top surface of the deck (Figure 5). At the same time, the edge beams were strengthened to either side of each primary beam using prepreg CFRP sheets, to transfer the additional cable loads that would result from (for example) motorised golf buggies.

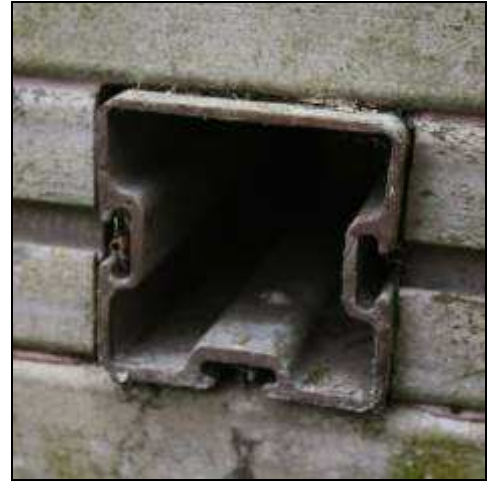
The cut ends of ACCS components were sealed using adhesive to prevent moisture ingress along the fibres, and this seal appears to be in generally good order (Figure 9b). The adhesive joints between the deck components (Figure 9a) also appear to be in good order, with no evidence of the crazing or discoloration that accompanies degradation. There are some small chips in the ACCS components that have left the fibres exposed, but these are very few.

(b) The sealed end of a transverse beam

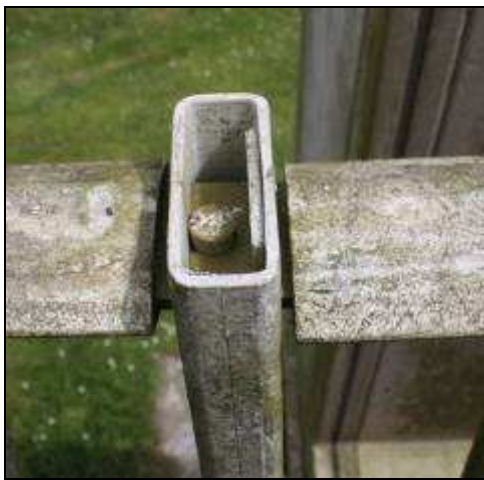
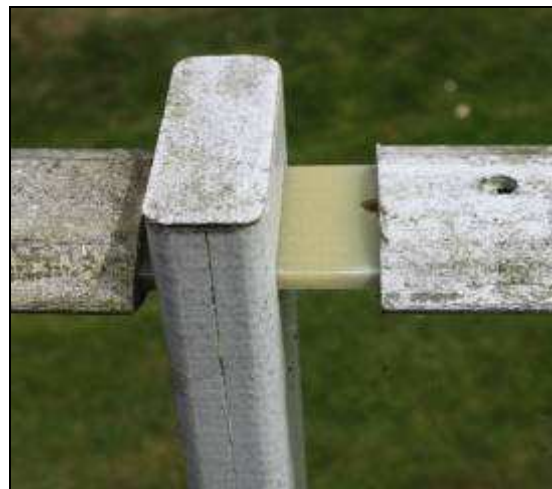
of the parapets as the bridge flexes; the sleeved plate was intended to provide damping through friction and hence improve the dynamic response of the bridge. The post-to-deck and rail-to-post connections have all worked loose, and there is considerable movement of the parapet components as the bridge flexes, but very little friction. Some top rail connections have become completely detached (Figure 12), and rudimentary repairs have been effected using screws and zip ties (Figure 13).

Figure 12. Details of the connection between the top handrail and parapet post (June 2008).

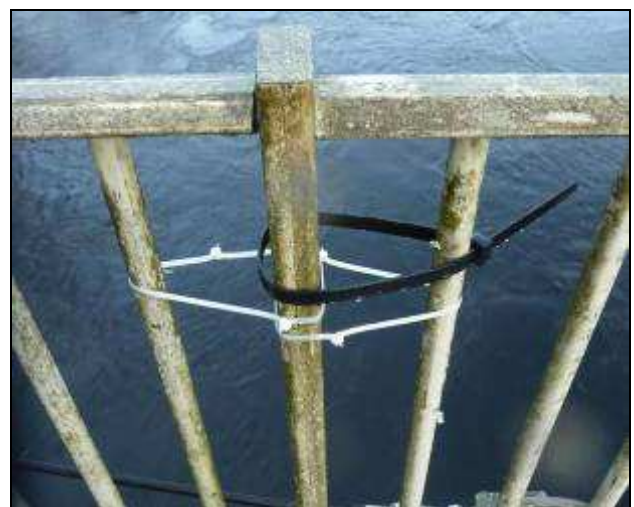
(b) Zip tie repair (December 2011)

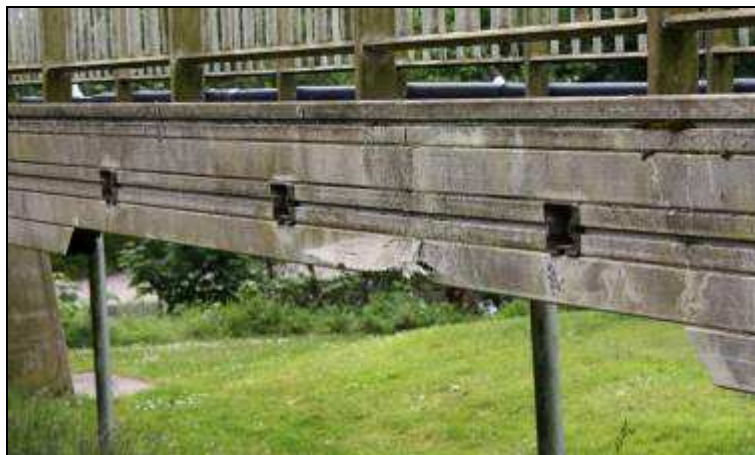
Figure 14 shows the most substantial impact damage, on the north back span, which has penetrated the lowest 3-way connector component. The damage is located mid-way between primary transverse beams, and consequently is unlikely to threaten the bridge's performance; however, it obviously results in a local loss of strength and allows environmental degradation of the GFRP.

(a) Location of the damage (June 2008)

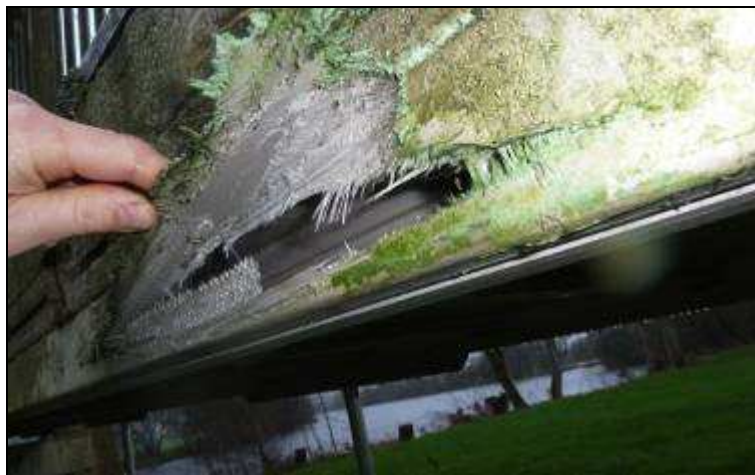
(b) Detail of the damage to the bottom 3-way component (December 2011)
