Behaviour of a concrete structure in a real compartment fire

In July 2006, a full-scale compartment fire was set in an existing block of flats in Dalmarnock, Glasgow, Scotland. Prior to ignition, the structure was instrumented with deflection gauges, thermocouples and strain gauges. The growth of the fire was also carefully monitored. The resulting data provided a unique record of the behaviour of a concrete structure in fire through a heating–cooling cycle. The results show significant variation in structural temperatures within a relatively small compartment, demonstrating that the assumption of uniform temperature at any level within a fire compartment, which is implicit in many simple design fires, is incorrect. The response of the structure showed a corresponding complexity due to the combination of non-uniform spatial and temporal heating and the structural boundary conditions.

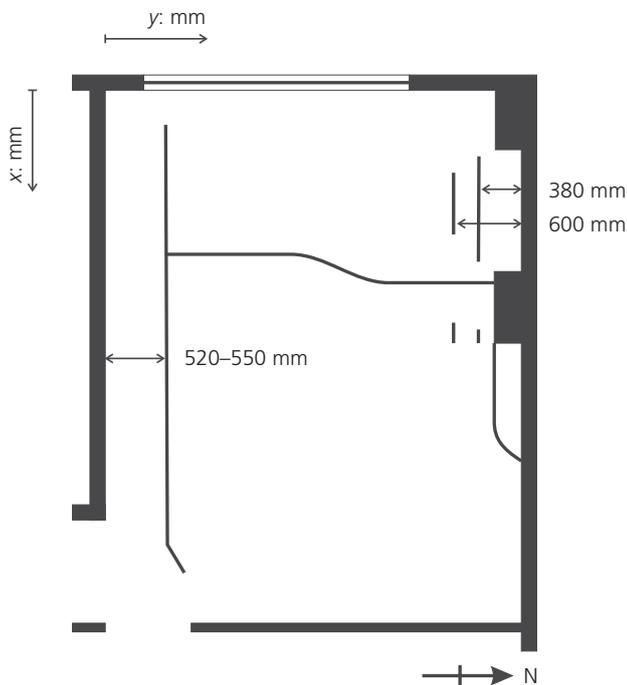
There was no evidence of any hot gases entering the room above the fire compartment. The upper surface of the slab contained visible cracks at the locations shown in Figure 9. These cracks generally coincided with the lines at which reinforcement in the upper part of the slab was curtailed (Figure 4). This is unsurprising, due to the step change in flexural capacity at these locations.

Figure 9. Crack pattern on the upper surface of the ceiling slab after the fire

Similar behaviour is seen along the east–west section (Figure 13), where a kink in the deflection profile around gauge B indicates the formation of another hogging crack (Figure 9). As previously noted, the eastern end ($x = 4.6$ m) of the scaffold tube used to support these deflection gauges was not a fixed point on the slab and so may itself have deflected.

is believed to be due to the formation of the hogging cracks across line 2 shown in Figure 9, resulting in compression close to the walls as the underside of the slab was cooled. The timing corresponds to the deflection profiles in Figure 12.

The cracks that appeared on the cool surface of the heated slab suggest that detailing of reinforcement may have implications for the behaviour of concrete structures in fire. These cracks and the resulting deflected profiles would not be predicted by current design methods. Although no compartmentation failure occurred as a result of cracking in the test considered here, the chances of such a failure would be greater with the longer spans and thinner slabs that are present in many modern buildings. Since the cracks appeared at locations where the flexural stiffness of the slab changed abruptly due to reinforcement curtailment, it would appear that specifying graduated reinforcement curtailment could reduce the chances of cracks forming during a fire.

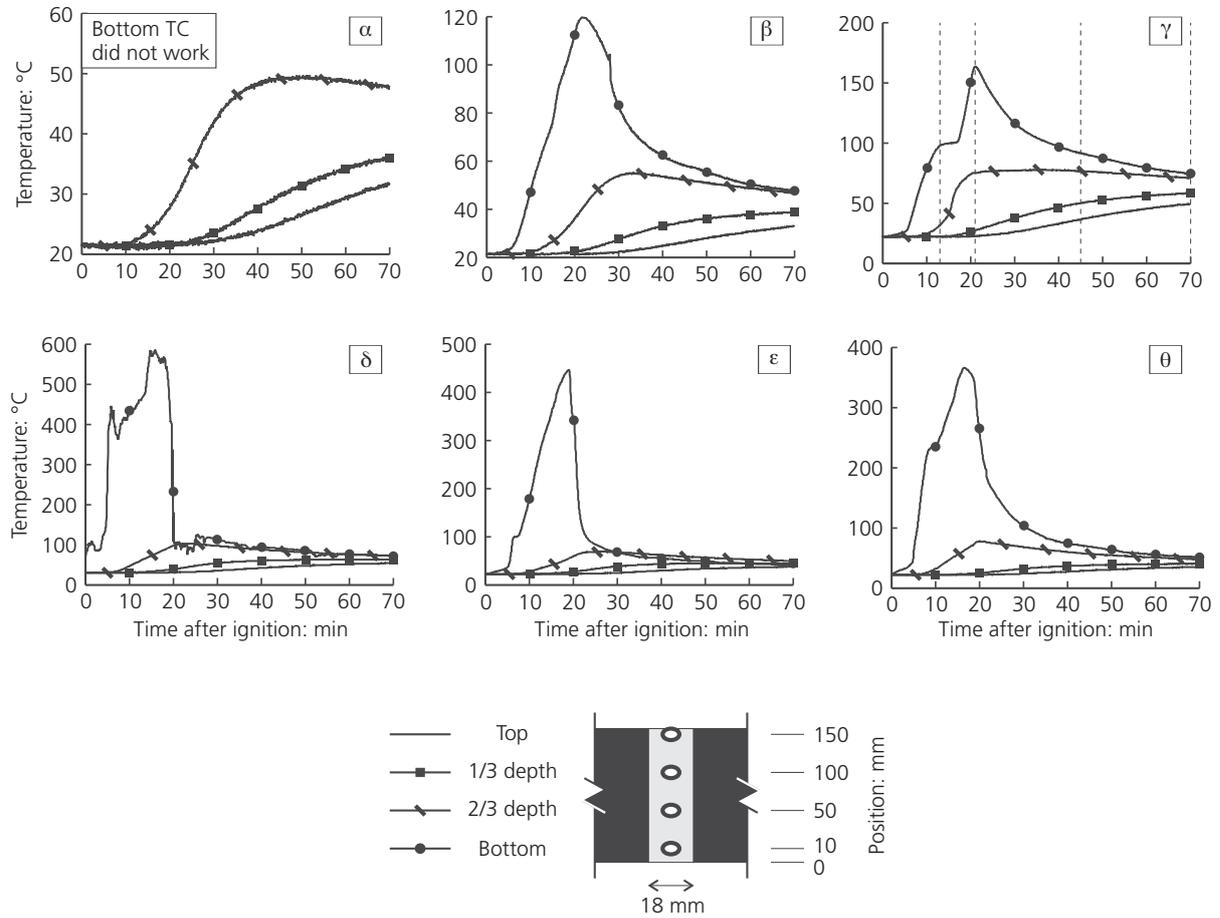
The highest temperatures were recorded at locations δ , ϵ and θ , away from the compartment window. This was because ventilation to the fire was initially supplied via the doorway to the hall (Figure 2). Of these three locations, δ was above the sofa and hence recorded the highest temperatures. Although θ was above the second largest fuel source (a bookcase heavily laden with combustible material), its location in the north-east corner of the room and adjacent to the cool slab in the kitchen meant that lower temperatures were recorded here than at locations δ or ϵ .

After the window of the compartment was broken, ventilation to the compartment changed, and there was an increase in the temperatures recorded at location γ . Locations α (in the south-east corner of the room) and β (near the window) remained relatively cool throughout the tests.

Figure 10. Temperature data recorded at the locations shown in Figure 6 (note the different temperature scales used at each location)

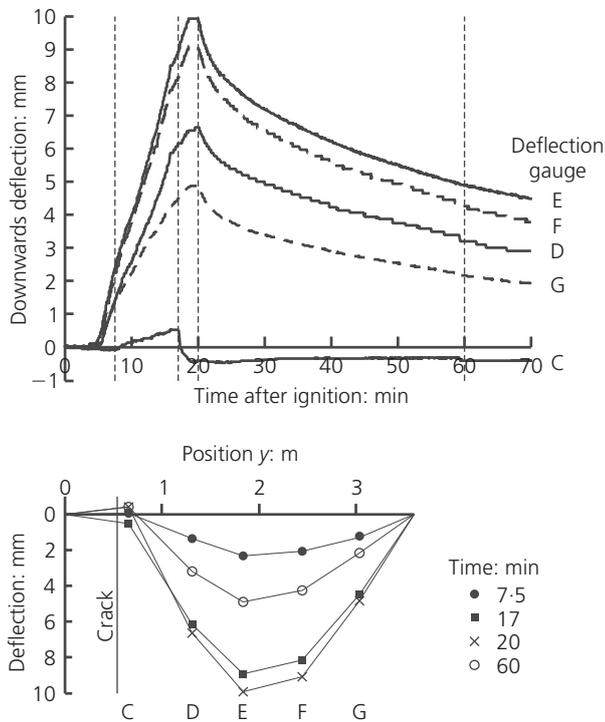
The peak deflection at the centre of the slab was around 10 mm, with 4 mm of this deflection recovered on cooling. Since the fire duration was short and high temperatures only penetrated a short distance into the concrete slab, the majority of the deflections recorded will have resulted from thermal curvature rather than from loss of material stiffness or strength. Across the north–south section (Figure 12), the deflections reduce towards the edges of the slab, as expected. It is notable that gauge C recorded negative (upward) deflections from around 18 min. This corresponds to the formation of a hogging crack in the slab that effectively moved the support from the wall to slightly inside the fire compartment. The crack formed slightly to the south of gauge C (Figure 9). As the fire cooled (Figure 8) but the upper layers of the slab continued to heat up (Figure 11), the deflection of the slab reduced but the hogging crack opened, as shown by the deflection profile at 60 min (Figure 12).

Figure 12. Vertical deflections along a north-south strip of the heated ceiling slab

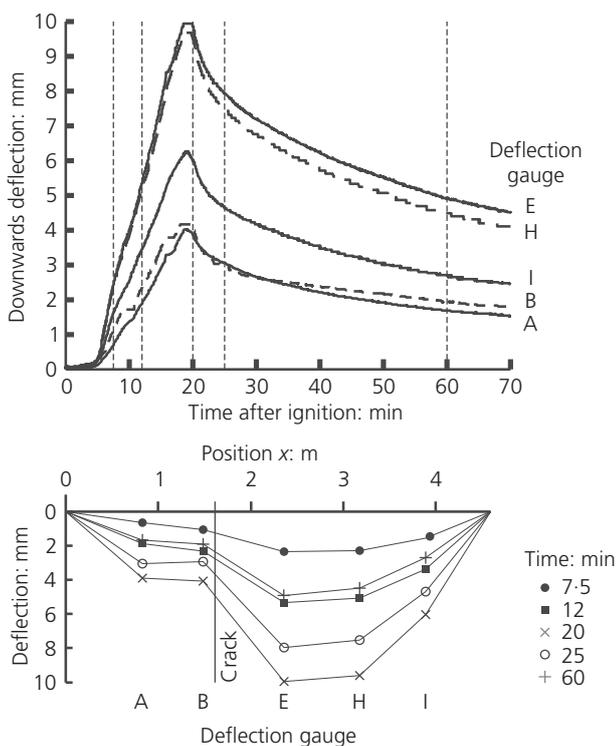
Figure 13. Vertical deflections along an east-west strip of the heated ceiling slab

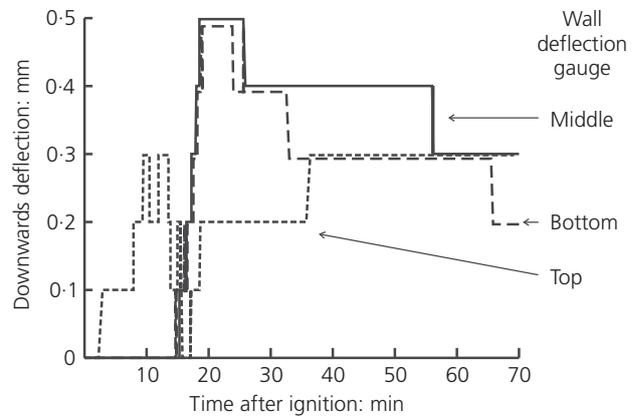
The very small horizontal deflections recorded for the internal wall of the compartment (Figure 14) show that the heating of this wall was small in comparison with that of the compartment ceiling.

Figure 14. Horizontal deflections of the internal structural wall of the fire compartment

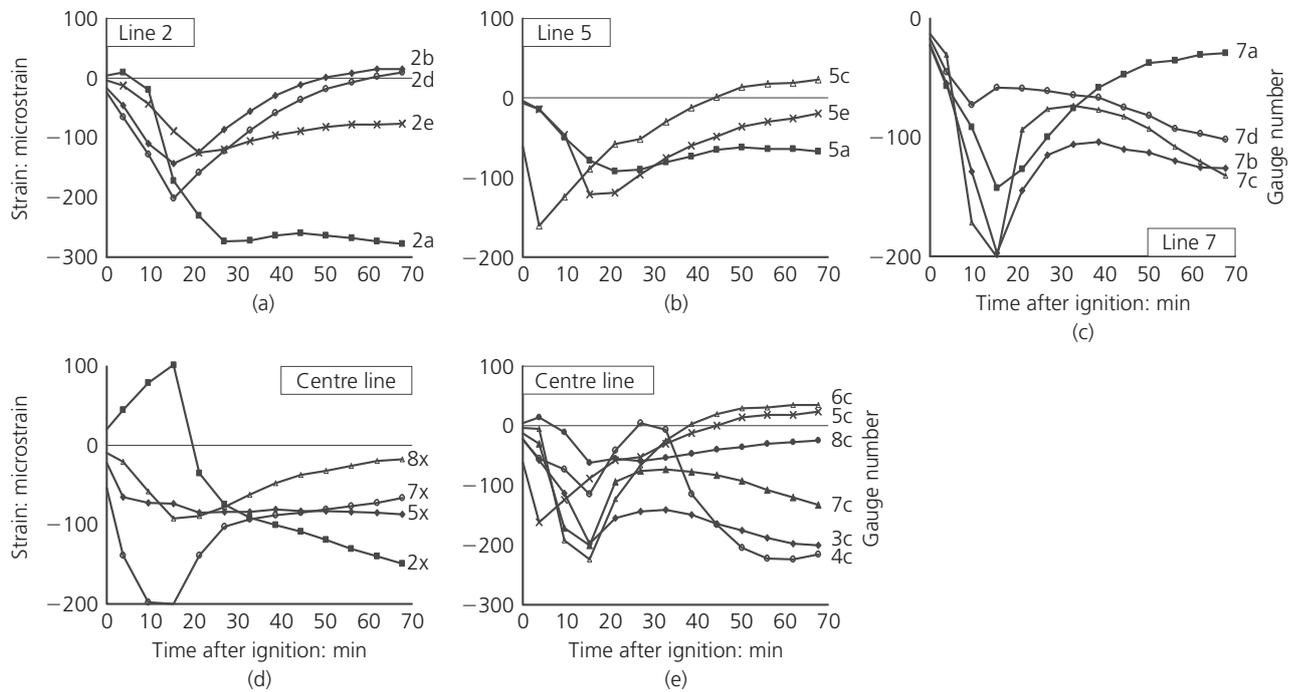
During the heating phase of the fire, the strains measured on the top of the slab increased rapidly. Heat from the fire caused the slab to expand, but it was the concrete in the lower parts of the slab that expanded, not the relatively cool upper surface where the strain gauges were located. The large compressive strains recorded on the top of the slab were dominated by geometrical compatibility with the surrounding structure and due to the internal self-equilibrating stresses created due to the thermal profile through the depth of the slab (Figure 11).

After the fire was extinguished at 19 min, the strains decayed rapidly as the bottom surface of the slab was cooled by water applied by the firefighters. However, the temperature in the upper parts of the slab continued to increase as residual heat conducted upwards (Figure 11). As a consequence, the compressive strains in gauges such as 3c and 7c (see Figure 7) again increased after around 30 min, due to the restrained thermal expansion of the top of the slab.

Figure 15. Strain gauge readings from the upper surface of heated slab at the locations indicated in Figure 7

structure during a realistic fire. In future tests it is recommended that higher resolution strain measurements are made in both time and space so that a full picture is possible of how strain develops within the slab.

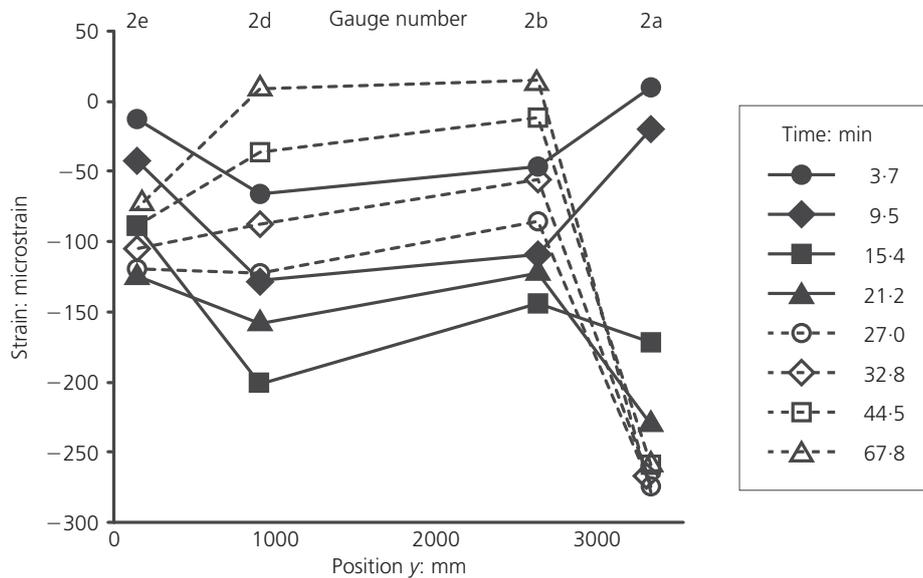
Figure 16 plots the strain profile with position along line 2 at selected time steps. During the heating phase (<19 min), the compressive strains are greater in the centre of the slab, as would be expected in a beam that is heated from underneath and is restrained against rotation and lateral expansion at either end. At 21.2 min (just after the fire was extinguished), there was a sudden jump in strain at gauge 2a and (to a lesser extent) gauge 2e. This

Figure 16. Strain profile with position along line 2 at selected time steps
