The Condition of the Aberfeldy Footbridge after 20 Years in Service

THE CONDITION OF THE ABERFELDY FOOTBRIDGE AFTER 20 YEARS OF SERVICE

Dr Tim Stratford
School of Engineering, The University of Edinburgh,
The King's Buildings, Edinburgh, EH9 3JL, Scotland
Email: Tim.Stratford@ed.ac.uk

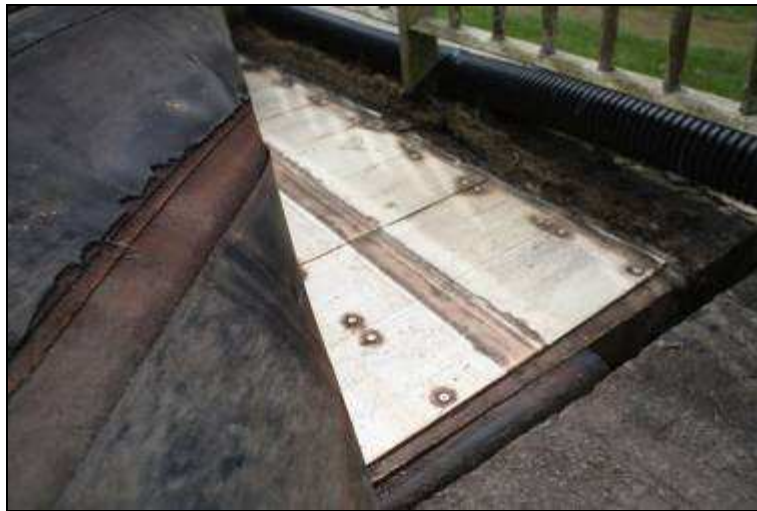
Figure 5. GFRP plates retrofitted to strengthen the bridge deck (June 2008)

The bridge was designed to a 5.6 kN/m pedestrian live load, and was not designed for the concentrated loads that result from motorised traffic. Consequently, the bridge was overloaded when it was crossed by a small tractor towing a trailer of sand, resulting in cracks in the top surface of the deck components (Cadei & Stratford, 2002).

The bridge was strengthened during 1997 by bonding and rivetting GFRP plates onto the top surface of the deck (Figure 5). At the same time, the edge beams were strengthened to either side of each primary beam using prepreg CFRP sheets, to transfer the additional cable loads that would result from (for example) motorised golf buggies.

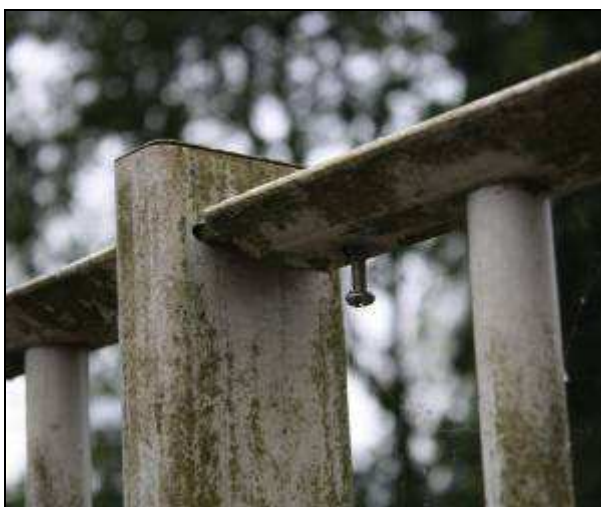
of the parapets as the bridge flexes; the sleeved plate was intended to provide damping through friction and hence improve the dynamic response of the bridge. The post-to-deck and rail-to-post connections have all worked loose, and there is considerable movement of the parapet components as the bridge flexes, but very little friction. Some top rail connections have become completely detached (Figure 12), and rudimentary repairs have been effected using screws and zip ties (Figure 13).

(a) Screw repair (June 2008)

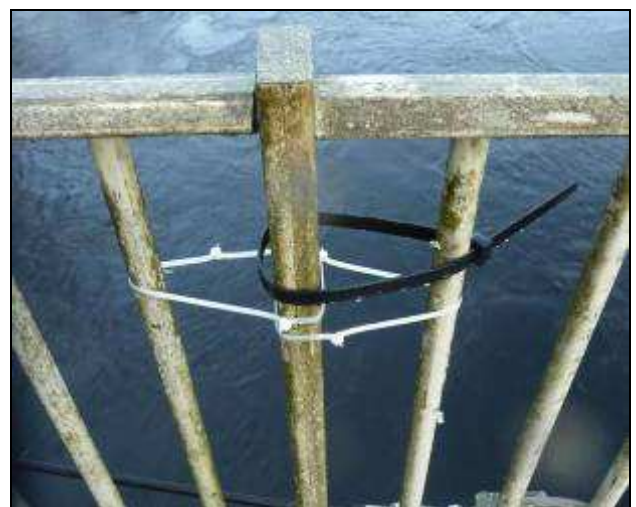
(b) Zip tie repair (December 2011)

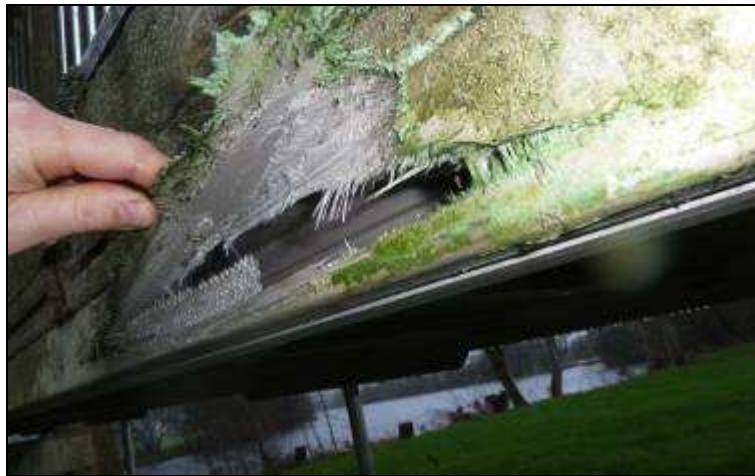
Figure 14 shows the most substantial impact damage, on the north back span, which has penetrated the lowest 3-way connector component. The damage is located mid-way between primary transverse beams, and consequently is unlikely to threaten the bridge's performance; however, it obviously results in a local loss of strength and allows environmental degradation of the GFRP.

(b) Detail of the damage to the bottom 3-way component (December 2011)
