The Condition of the Aberfeldy Footbridge after 20 Years in Service

THE CONDITION OF THE ABERFELDY FOOTBRIDGE AFTER 20 YEARS OF SERVICE

Dr Tim Stratford
School of Engineering, The University of Edinburgh,
The King's Buildings, Edinburgh, EH9 3JL, Scotland
Email: Tim.Stratford@ed.ac.uk

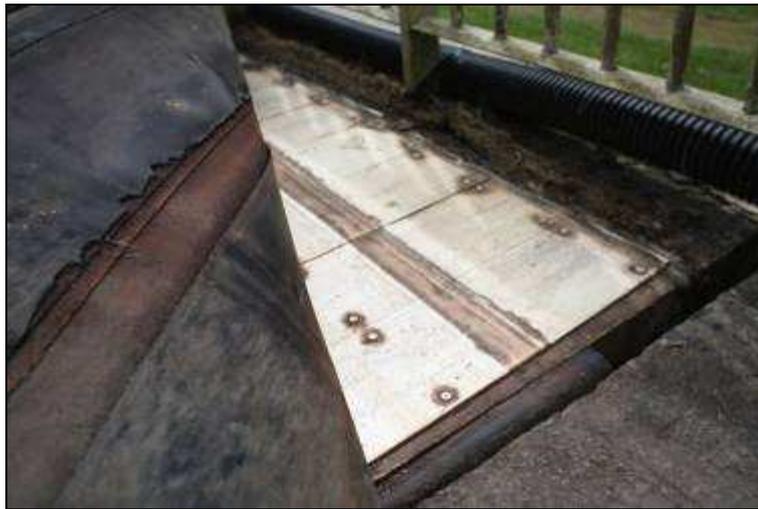
Figure 5. GFRP plates retrofitted to strengthen the bridge deck (June 2008)

The bridge was strengthened during 1997 by bonding and rivetting GFRP plates onto the top surface of the deck (Figure 5). At the same time, the edge beams were strengthened to either side of each primary beam using prepreg CFRP sheets, to transfer the additional cable loads that would result from (for example) motorised golf buggies.

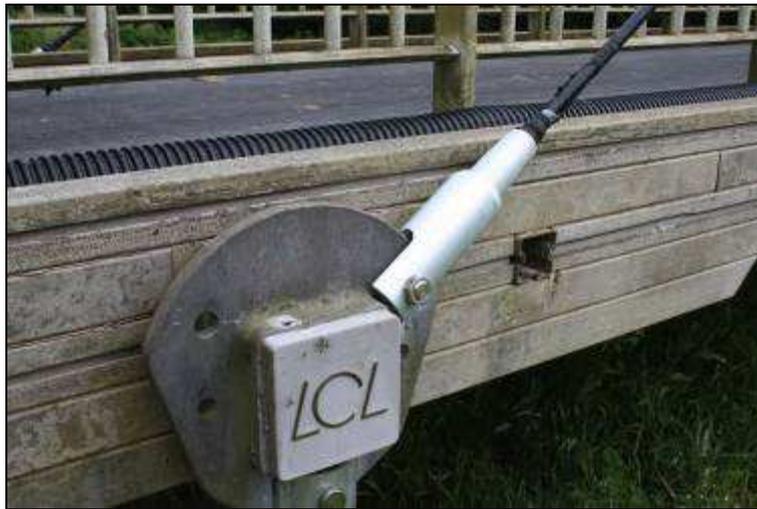
Figure 7. Anchorage of a cable to the bridge deck (June 2008).

The primary structure of the bridge continues to perform well, with no visual signs of overall structural deterioration. Whilst a visual inspection will not detect every deficiency, FRP composites are brittle and hence structural deterioration usually results in cracks in the GFRP components. Careful inspections of the bridge deck have not revealed damage that is a result of structural deficiency, but impact damage has occurred that will be discussed below. The bridge deck has a smooth curve and there is no evidence of movement of the towers, deck, foundations or abutments. There are no slack cables, and there is no sign that the cables have pulled out from their anchorages (Figure 7).

The aramid stay cable ropes incorporate a polyethylene sheath that protects them from moisture ingress and UV corrosion. The cables were over-wrapped where they joined with the aluminium anchorage to ensure protection, but this over-wrap has degraded, potentially leaving a path for moisture ingress into the critical anchorage detail (Figure 7).

These details are relatively straightforward to repair, together with preventative maintenance such as cleaning the deck and replacing the over-wrap layer that protected the connection between the aramid stay cables and the aluminium anchorages. However, the bridge receives minimal maintenance by a non-expert owner. Where repairs have been conducted, they have used traditional techniques such as screwing into the GFRP components, and there is a danger that this could cause long-term damage to the GFRP.

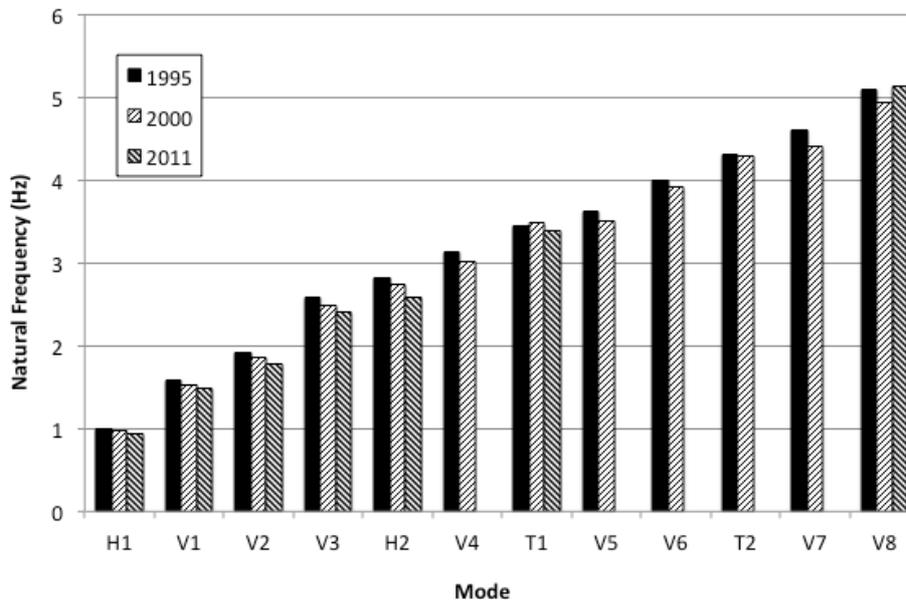
Figure 8. Dynamic response of Aberfeldy Footbridge in 1995, 2000 and 2012.

The reduction in natural frequencies between 1995 and 2000 was previously attributed to the increase in mass of the deck due to the strengthening work (Cadei & Stratford, 2002), but Figure 8 shows a further in the natural frequencies between 2000 and 2011. This could be attributed to an increase in mass of the bridge deck due to moisture absorption (GFRP can absorb up to 1.5% moisture by weight), or potentially due to reduction in the stiffness of the GFRP. It must be noted, however, that the 2011 values were obtained in winter, after a period of extended wet weather and cold temperatures. The moisture content of the GFRP will undergo seasonal variations and the bridge stiffness is potentially affected by temperature, consequently the reduction in natural frequencies cannot be taken as a conclusive indicator of structural performance.

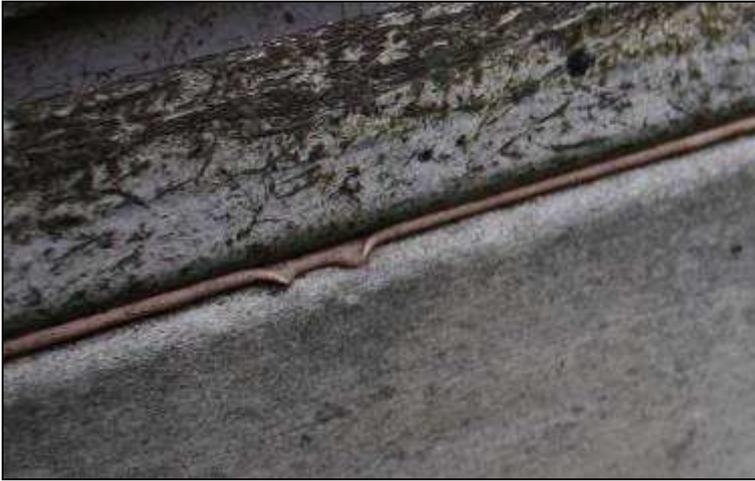
The cut ends of ACCS components were sealed using adhesive to prevent moisture ingress along the fibres, and this seal appears to be in generally good order (Figure 9b). The adhesive joints between the deck components (Figure 9a) also appear to be in good order, with no evidence of the crazing or discoloration that accompanies degradation. There are some small chips in the ACCS components that have left the fibres exposed, but these are very few.

(a) GFRP and adhesive joint condition on bridge deck

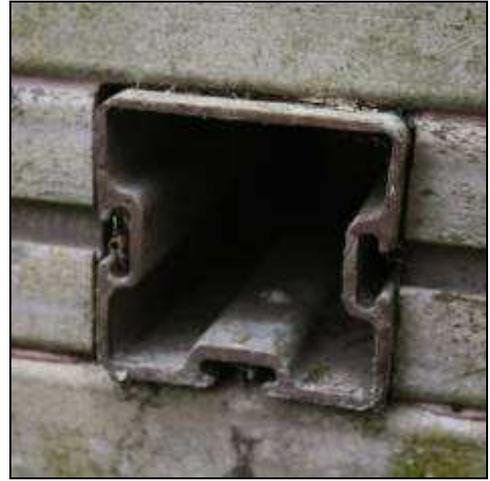
(b) The sealed end of a transverse beam

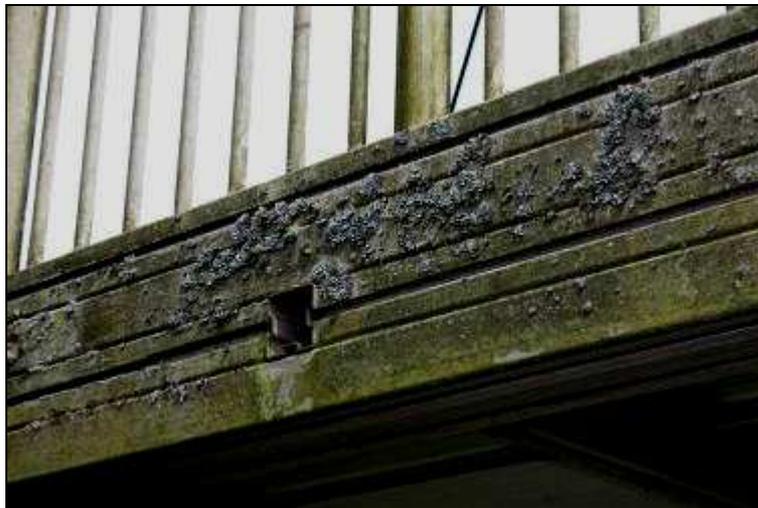
Figure 10. Greening of the bridge deck (June 2008).

The elevations of the bridge are greening-over, due to the growth of moulds, lichens and moss (Figure 10). The grooves and connections on the side of deck trap water supplies for growth. The growth is no more than would be expected on a timber bridge. Provided that it is a surface growth, this greening of the bridge will not affect the structural performance of the bridge, but it could exacerbate degradation where the surface veil of the components has occurred. There is very little growth where over the carbon strengthening around the primary transverse beams (Figure 6), due to fewer indentations that trap water, and due to the use of a resin that inhibits growth.

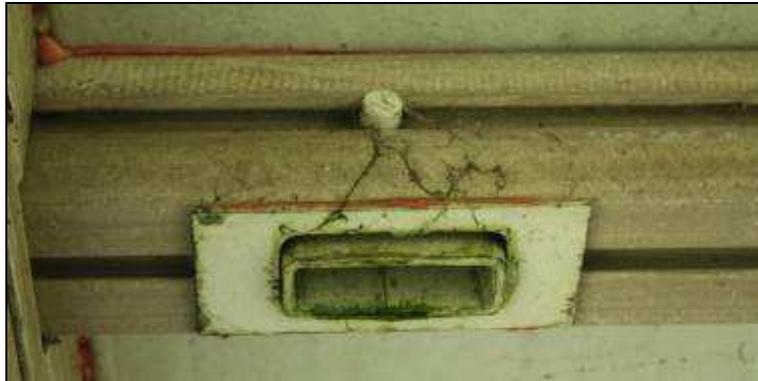
Figure 11. Connection of the parapet post beneath the bridge deck (June 2008).

The parapet posts pass through the deck, and were doweled beneath the deck (Figure 11) and bonded to the top of the deck. The top and bottom rails are connected to the parapet posts by means of a sleeved plate that passes through the post (Figure 12). This arrangement was designed to accommodate movement

of the parapets as the bridge flexes; the sleeved plate was intended to provide damping through friction and hence improve the dynamic response of the bridge. The post-to-deck and rail-to-post connections have all worked loose, and there is considerable movement of the parapet components as the bridge flexes, but very little friction. Some top rail connections have become completely detached (Figure 12), and rudimentary repairs have been effected using screws and zip ties (Figure 13).

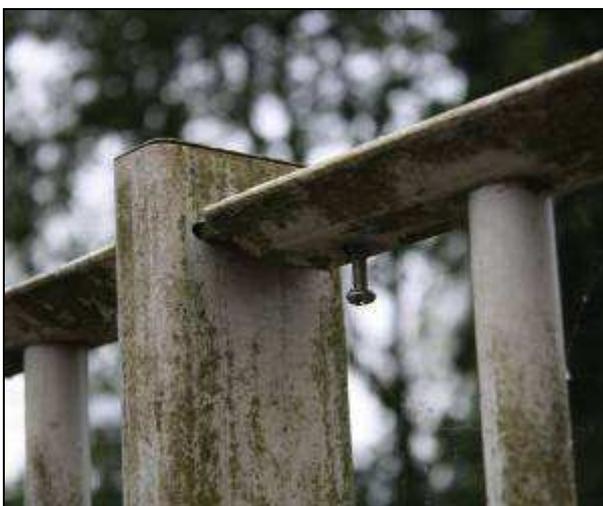
(a) Screw repair (June 2008)

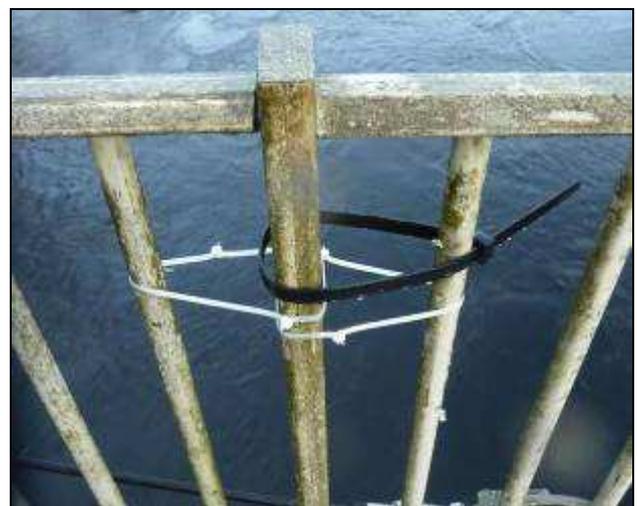
(b) Zip tie repair (December 2011)

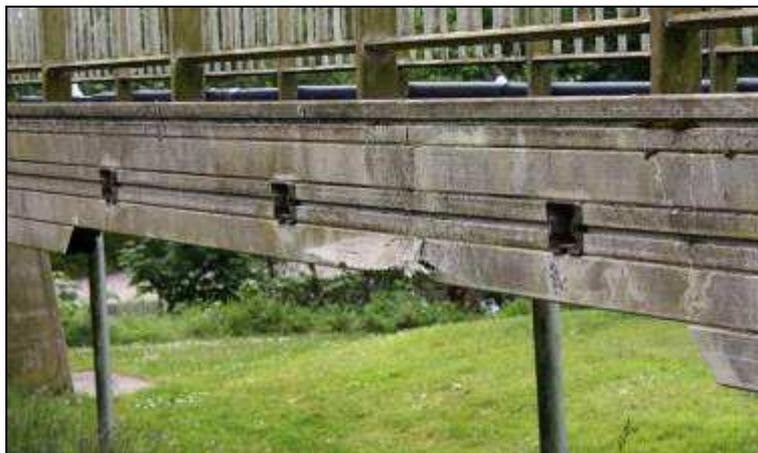
Figure 14 shows the most substantial impact damage, on the north back span, which has penetrated the lowest 3-way connector component. The damage is located mid-way between primary transverse beams, and consequently is unlikely to threaten the bridge's performance; however, it obviously results in a local loss of strength and allows environmental degradation of the GFRP.

(a) Location of the damage (June 2008)

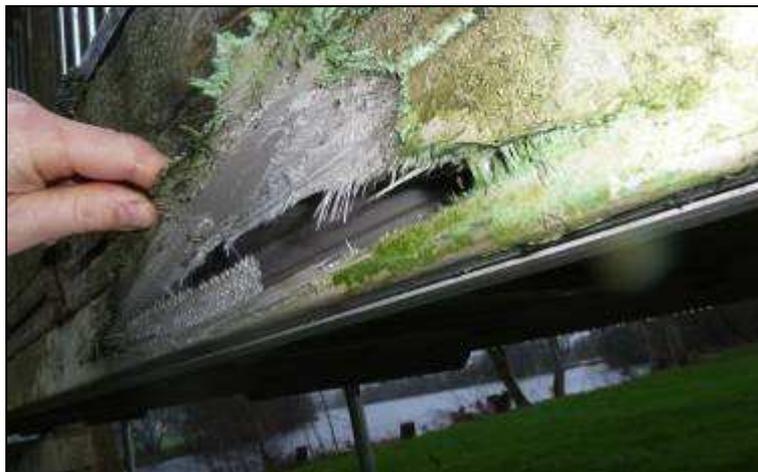
(b) Detail of the damage to the bottom 3-way component (December 2011)

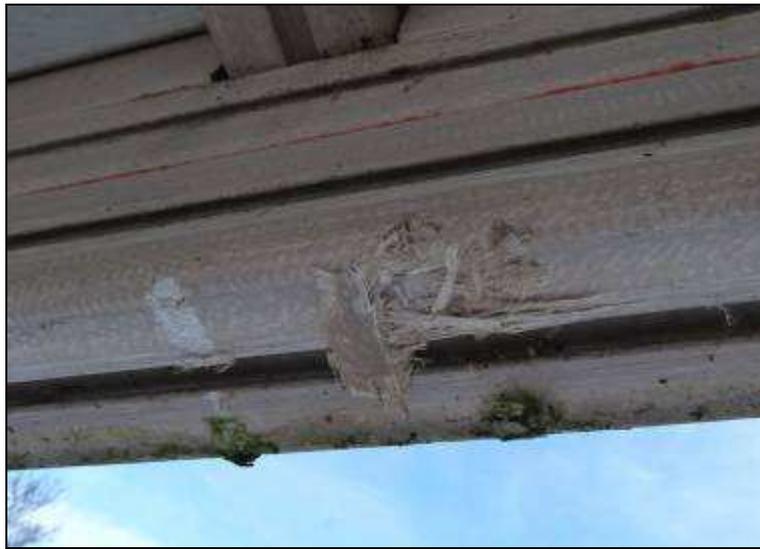
Another example of impact damage to the underside of the deck is shown in Figure 15, while Figure 16 shows that an aluminium angle has been added to protect (or possibly repair) the underside of the deck adjacent to the south tower. Fixing this angle using screws is not ideal, as it is likely to result in splitting between the glass fibres, resulting in accelerated degradation of the GFRP.

Figure 15. Impact damage to the underside of the deck (December 2010).

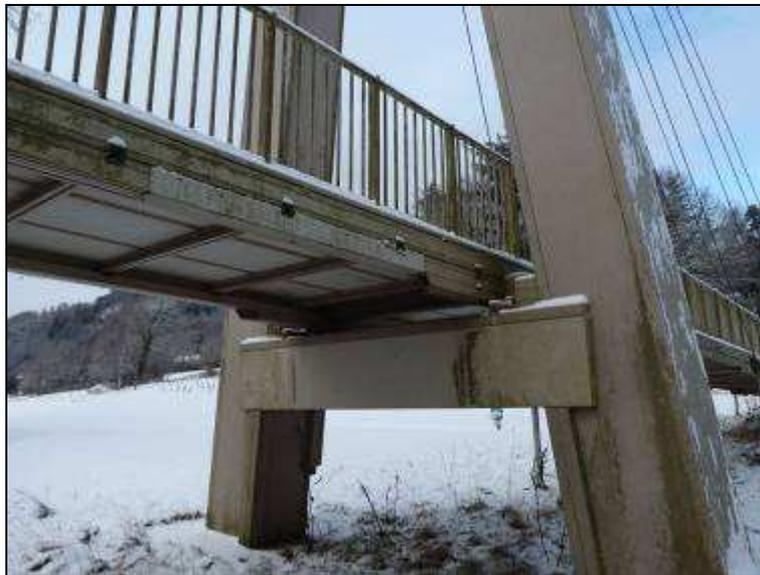
Figure 16. Impact protection applied beneath the deck (December 2010).

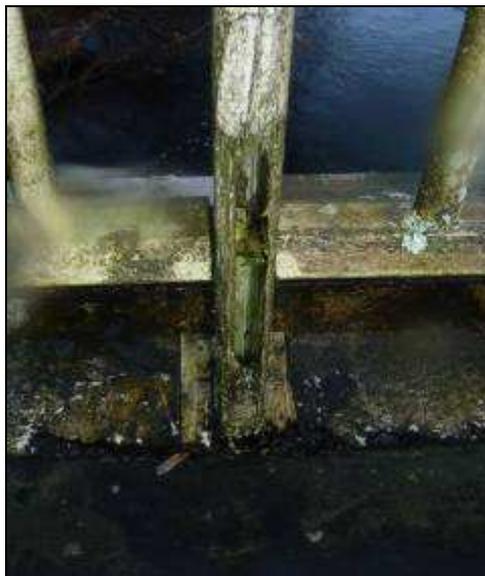
In 2002, the base of the parapet posts were noted to be 'badly scuffed' (Cadei & Stratford, 2002). Figure 17 shows how after another ten years service, the base of some posts are now severely damaged, with substantial loss of section due to impact and abrasion. These posts require repair, and should be protected using a kick board. Separate impact protection has also been added to the northern end of the parapets (Figure 2).

Figure 17. Impact damage to the bottom of a parapet post (December 2011).
