## The Condition of the Aberfeldy Footbridge after 20 Years in Service

# THE CONDITION OF THE ABERFELDY FOOTBRIDGE AFTER 20 YEARS OF SERVICE

Dr Tim Stratford  
School of Engineering, The University of Edinburgh,  
The King's Buildings, Edinburgh, EH9 3JL, Scotland  
Email: [Tim.Stratford@ed.ac.uk](mailto:Tim.Stratford@ed.ac.uk)

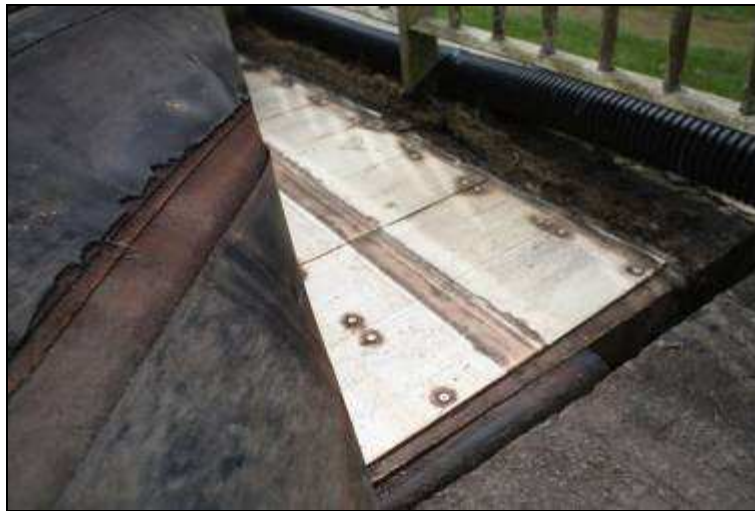
The bridge was designed to a 5.6 kN/m pedestrian live load, and was not designed for the concentrated loads that result from motorised traffic. Consequently, the bridge was overloaded when it was crossed by a small tractor towing a trailer of sand, resulting in cracks in the top surface of the deck components (Cadei & Stratford, 2002).

The bridge was strengthened during 1997 by bonding and rivetting GFRP plates onto the top surface of the deck (Figure 5). At the same time, the edge beams were strengthened to either side of each primary beam using prepreg CFRP sheets, to transfer the additional cable loads that would result from (for example) motorised golf buggies.

Figure 5. GFRP plates retrofitted to strengthen the bridge deck (June 2008)

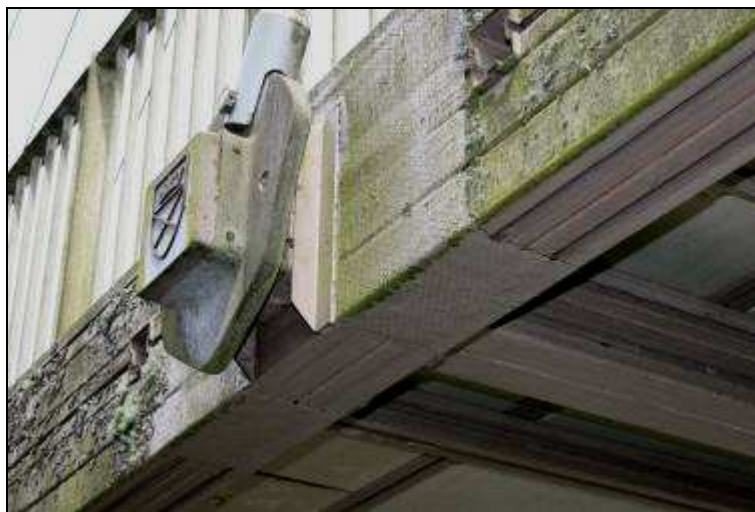
Figure 6. CFRP strengthening retrofitted around a primary transverse beam (June 2008)

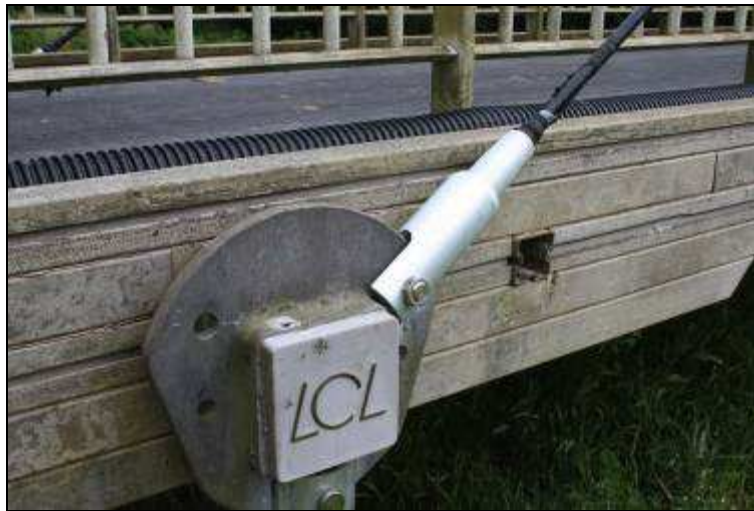
Figure 7. Anchorage of a cable to the bridge deck (June 2008).

The aramid stay cable ropes incorporate a polyethylene sheath that protects them from moisture ingress and UV corrosion. The cables were over-wrapped where they joined with the aluminium anchorage to ensure protection, but this over-wrap has degraded, potentially leaving a path for moisture ingress into the critical anchorage detail (Figure 7).

These details are relatively straightforward to repair, together with preventative maintenance such as cleaning the deck and replacing the over-wrap layer that protected the connection between the aramid stay cables and the aluminium anchorages. However, the bridge receives minimal maintenance by a non-expert owner. Where repairs have been conducted, they have used traditional techniques such as screwing into the GFRP components, and there is a danger that this could cause long-term damage to the GFRP.

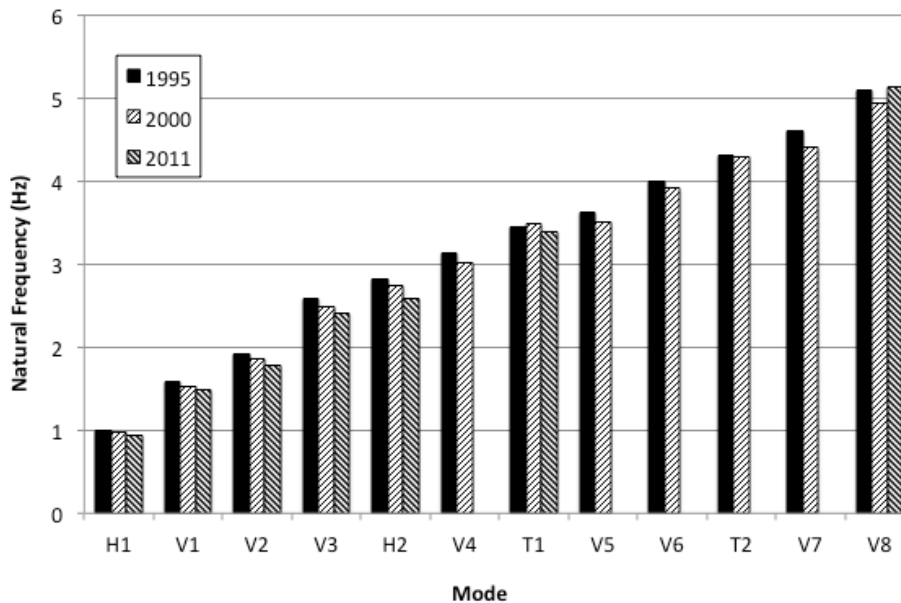
Figure 8. Dynamic response of Aberfeldy Footbridge in 1995, 2000 and 2012.

The reduction in natural frequencies between 1995 and 2000 was previously attributed to the increase in mass of the deck due to the strengthening work (Cadei & Stratford, 2002), but Figure 8 shows a further in the natural frequencies between 2000 and 2011. This could be attributed to an increase in mass of the bridge deck due to moisture absorption (GFRP can absorb up to 1.5% moisture by weight), or potentially due to reduction in the stiffness of the GFRP. It must be noted, however, that the 2011 values were obtained in winter, after a period of extended wet weather and cold temperatures. The moisture content of the GFRP will undergo seasonal variations and the bridge stiffness is potentially affected by temperature, consequently the reduction in natural frequencies cannot be taken as a conclusive indicator of structural performance.

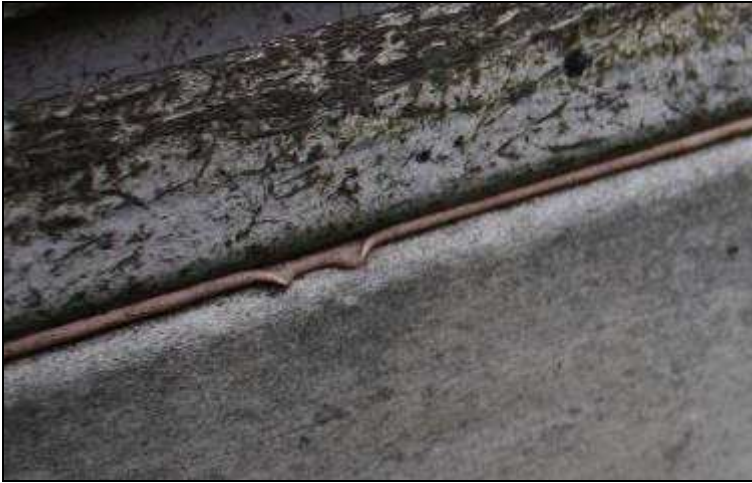
The cut ends of ACCS components were sealed using adhesive to prevent moisture ingress along the fibres, and this seal appears to be in generally good order (Figure 9b). The adhesive joints between the deck components (Figure 9a) also appear to be in good order, with no evidence of the crazing or discoloration that accompanies degradation. There are some small chips in the ACCS components that have left the fibres exposed, but these are very few.

(a) GFRP and adhesive joint condition on bridge deck

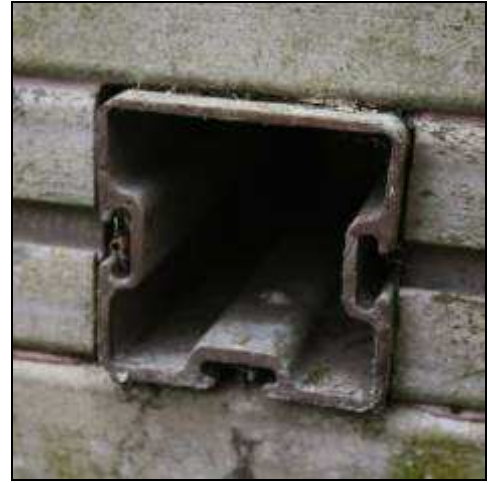
(b) The sealed end of a transverse beam

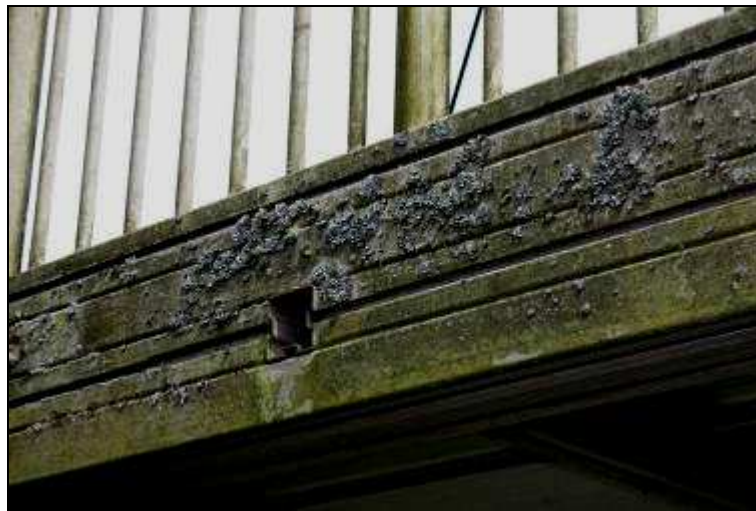
The elevations of the bridge are greening-over, due to the growth of moulds, lichens and moss (Figure 10). The grooves and connections on the side of deck trap water supplies for growth. The growth is no more than would be expected on a timber bridge. Provided that it is a surface growth, this greening of the bridge will not affect the structural performance of the bridge, but it could exacerbate degradation where the surface veil of the components has occurred. There is very little growth where over the carbon strengthening around the primary transverse beams (Figure 6), due to fewer indentations that trap water, and due to the use of a resin that inhibits growth.

Figure 10. Greening of the bridge deck (June 2008).

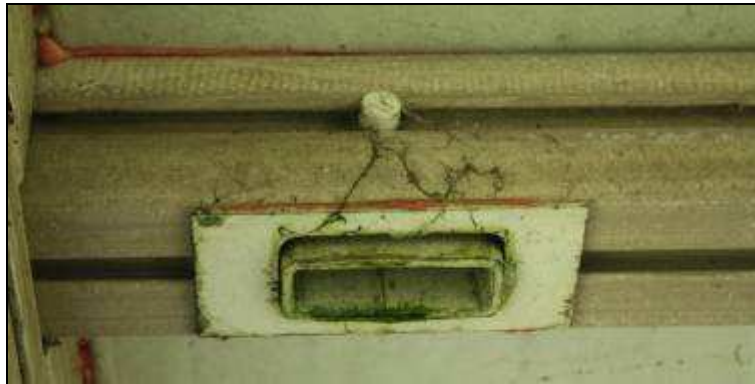
The parapet posts pass through the deck, and were doweled beneath the deck (Figure 11) and bonded to the top of the deck. The top and bottom rails are connected to the parapet posts by means of a sleeved plate that passes through the post (Figure 12). This arrangement was designed to accommodate movement

of the parapets as the bridge flexes; the sleeved plate was intended to provide damping through friction and hence improve the dynamic response of the bridge. The post-to-deck and rail-to-post connections have all worked loose, and there is considerable movement of the parapet components as the bridge flexes, but very little friction. Some top rail connections have become completely detached (Figure 12), and rudimentary repairs have been effected using screws and zip ties (Figure 13).

Figure 11. Connection of the parapet post beneath the bridge deck (June 2008).

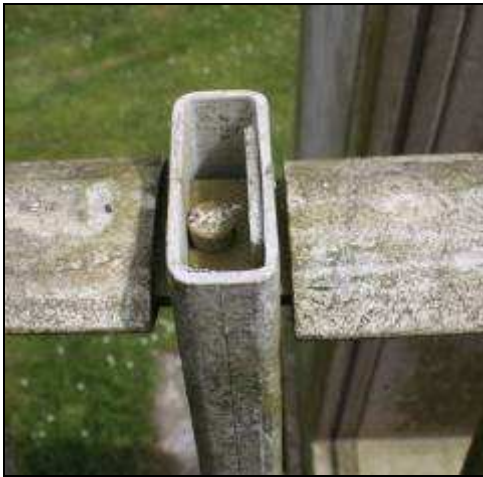
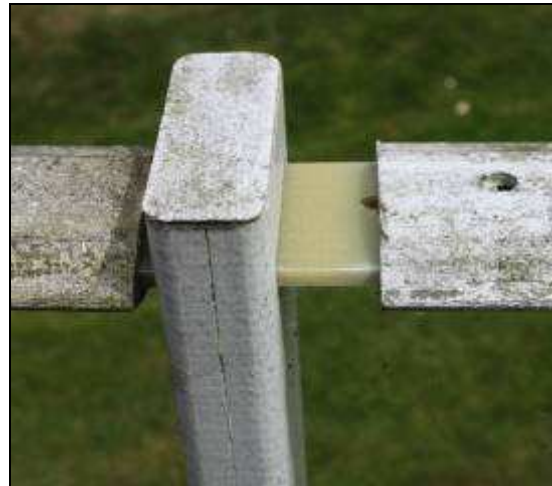
Figure 12. Details of the connection between the top handrail and parapet post (June 2008).

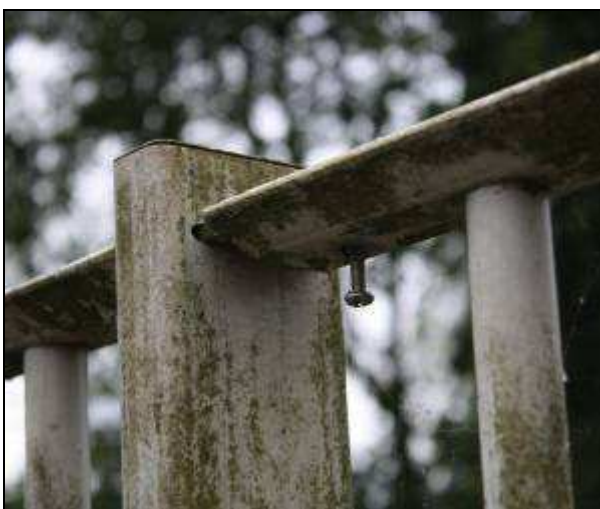
(a) Screw repair (June 2008)

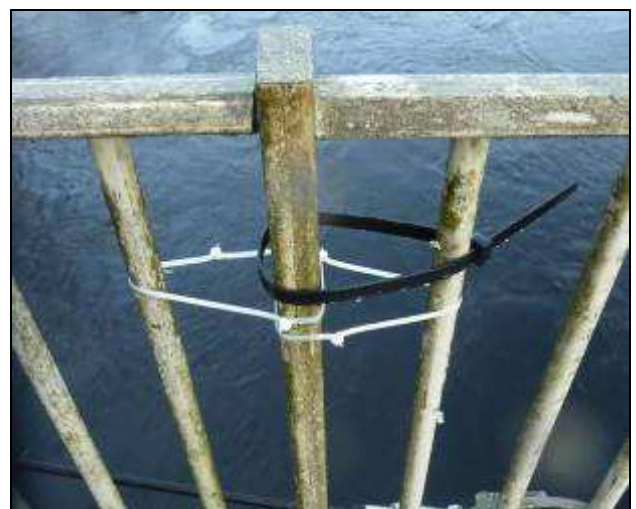
(b) Zip tie repair (December 2011)

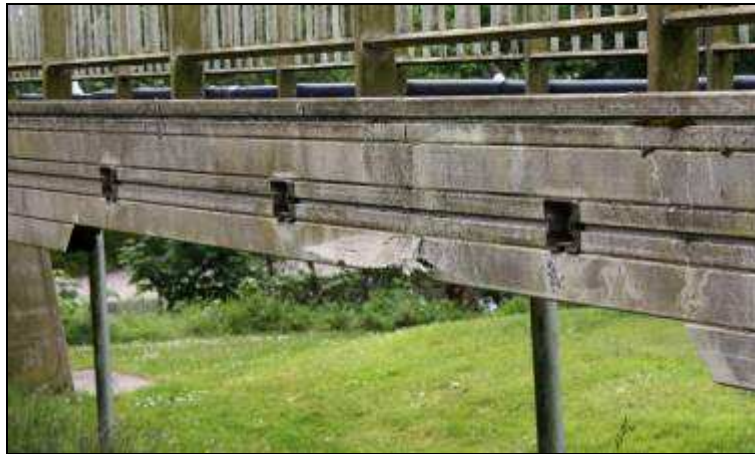
Figure 14 shows the most substantial impact damage, on the north back span, which has penetrated the lowest 3-way connector component. The damage is located mid-way between primary transverse beams, and consequently is unlikely to threaten the bridge's performance; however, it obviously results in a local loss of strength and allows environmental degradation of the GFRP.

(a) Location of the damage (June 2008)

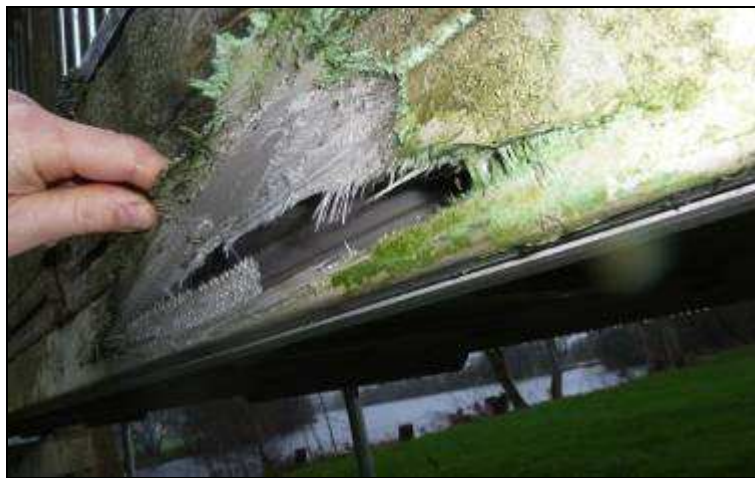
(b) Detail of the damage to the bottom 3-way component (December 2011)

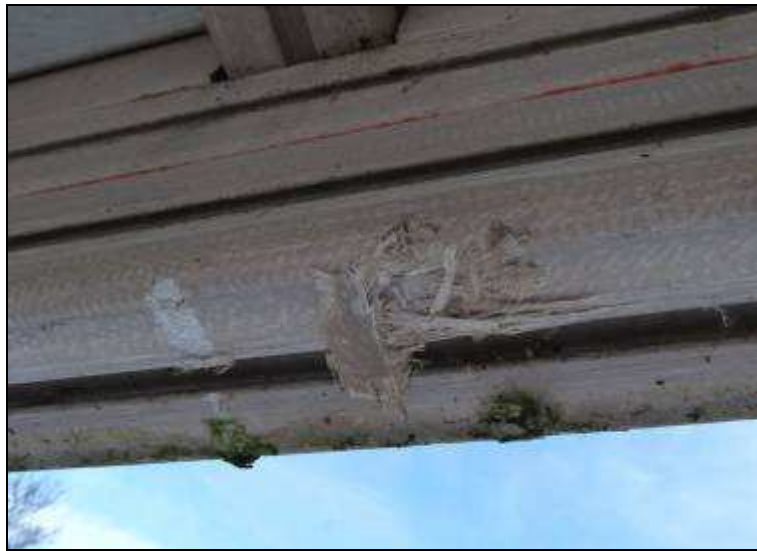
Another example of impact damage to the underside of the deck is shown in Figure 15, while Figure 16 shows that an aluminium angle has been added to protect (or possibly repair) the underside of the deck adjacent to the south tower. Fixing this angle using screws is not ideal, as it is likely to result in splitting between the glass fibres, resulting in accelerated degradation of the GFRP.

Figure 15. Impact damage to the underside of the deck (December 2010).

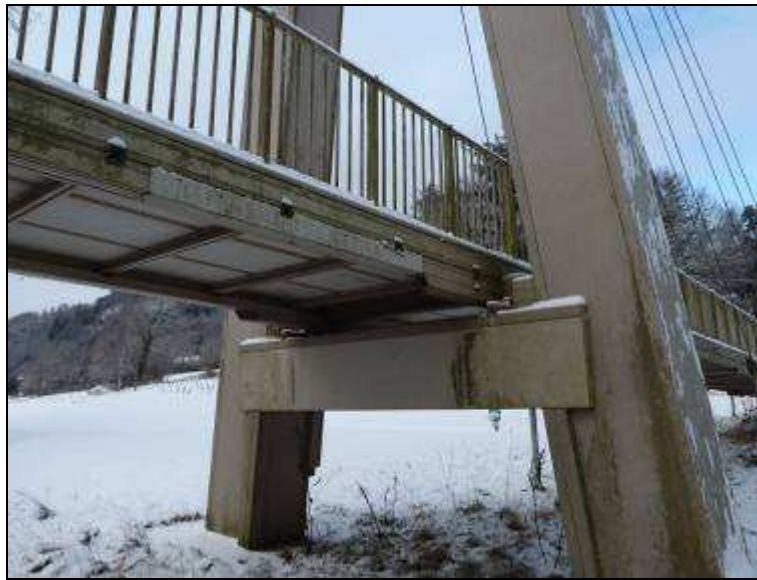
Figure 16. Impact protection applied beneath the deck (December 2010).

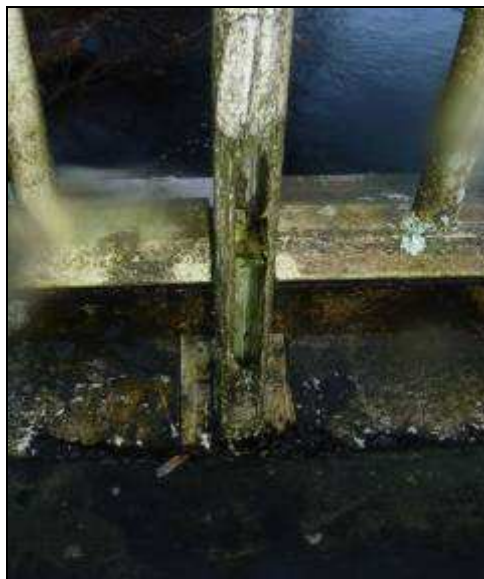
In 2002, the base of the parapet posts were noted to be 'badly scuffed' (Cadei & Stratford, 2002). Figure 17 shows how after another ten years service, the base of some posts are now severely damaged, with substantial loss of section due to impact and abrasion. These posts require repair, and should be protected using a kick board. Separate impact protection has also been added to the northern end of the parapets (Figure 2).

Figure 17. Impact damage to the bottom of a parapet post (December 2011).
