## The Condition of the Aberfeldy Footbridge after 20 Years in Service

# THE CONDITION OF THE ABERFELDY FOOTBRIDGE AFTER 20 YEARS OF SERVICE

Dr Tim Stratford  
School of Engineering, The University of Edinburgh,  
The King's Buildings, Edinburgh, EH9 3JL, Scotland  
Email: [Tim.Stratford@ed.ac.uk](mailto:Tim.Stratford@ed.ac.uk)

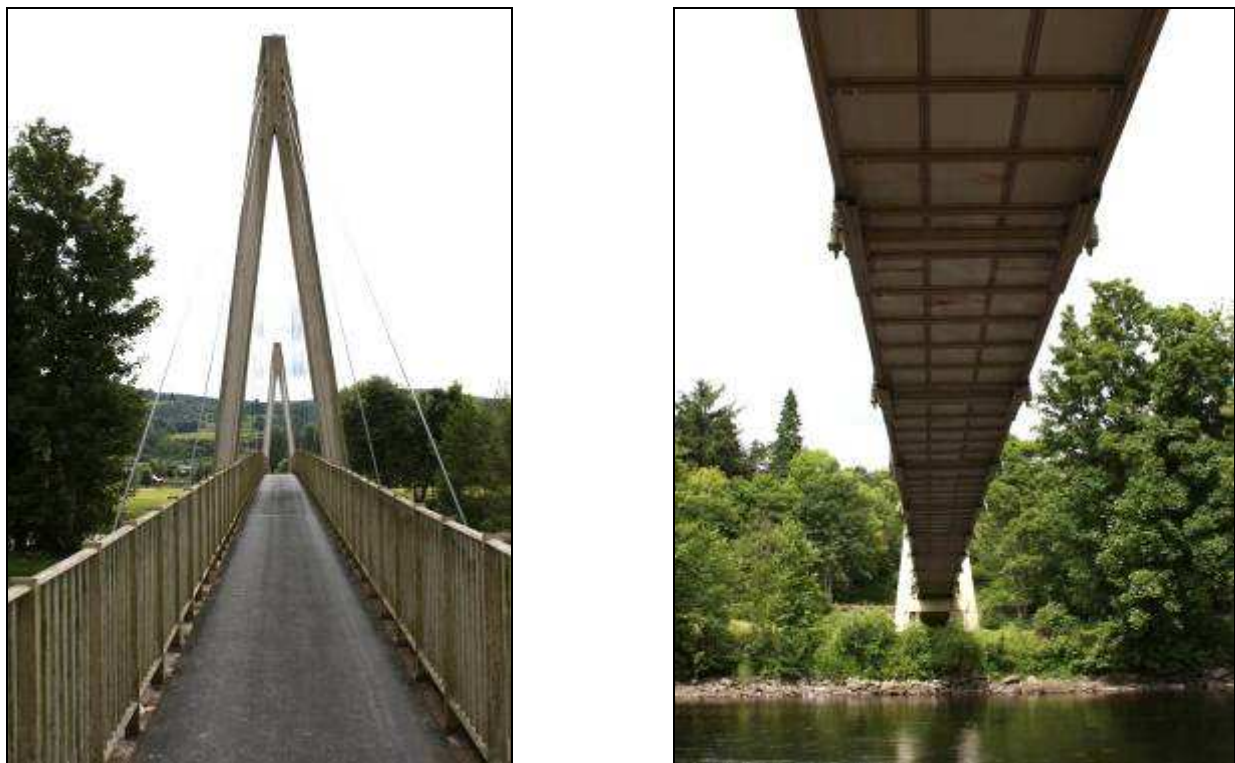
Figure 4. Aberfeldy footbridge from above and below the bridge deck (June 2008)

The parapets consist of rectangular parapet posts, top and bottom rails, and closely spaced circular vertical members (Figure 4). These were all standard GFRP pultrusions, although they were not produced to the same specification as the ACCS deck components. The parapet components consequently exhibit greater erosion of the surface veil, with many regions of exposed fibres, particularly on the bottom rail due to a combination of abrasion and weathering.
