Behaviour of a concrete structure in a real compartment fire

In July 2006, a full-scale compartment fire was set in an existing block of flats in Dalmarnock, Glasgow, Scotland. Prior to ignition, the structure was instrumented with deflection gauges, thermocouples and strain gauges. The growth of the fire was also carefully monitored. The resulting data provided a unique record of the behaviour of a concrete structure in fire through a heating–cooling cycle. The results show significant variation in structural temperatures within a relatively small compartment, demonstrating that the assumption of uniform temperature at any level within a fire compartment, which is implicit in many simple design fires, is incorrect. The response of the structure showed a corresponding complexity due to the combination of non-uniform spatial and temporal heating and the structural boundary conditions.

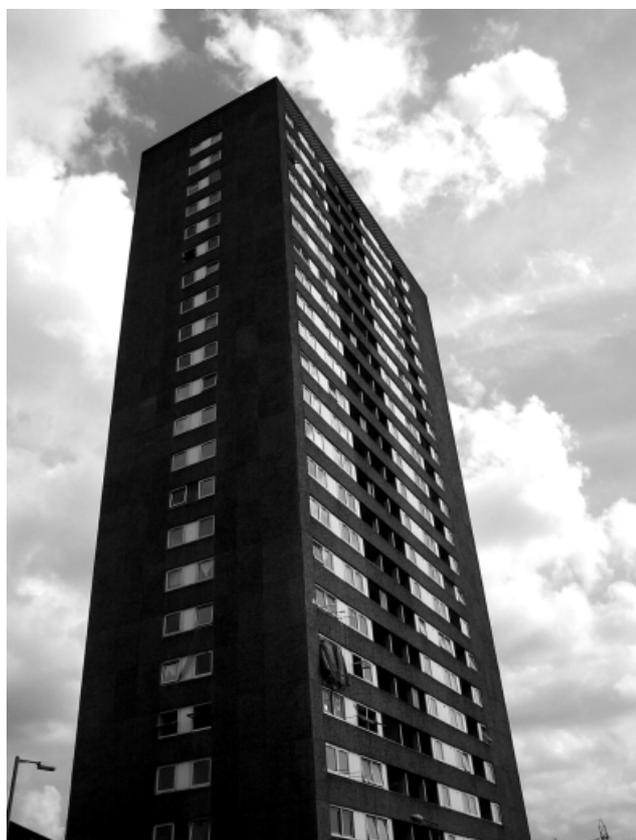
Figure 1. 4 Millerfield Place, Dalmarnock, the location of the fire test

The structure in which the fire test was carried out was built in 1964 as a residential tower block. The 23-storey building was made of cast-in-situ reinforced concrete and each floor contained six flats. Figure 1 gives a general view of the structure. The fire test was conducted in a flat on the fourth floor and the fire compartment was in the living room of the flat. A plan view of the flat, based on an extract from the blueprints of the structure and indicating aspects of the test set-up, is shown in Figure 2. Details of the living room, including key dimensions, are indicated in Figure 3. The figure also shows the x - y coordinate system and north direction used throughout the tests. The floor to ceiling height was 2.4 m throughout the flat.

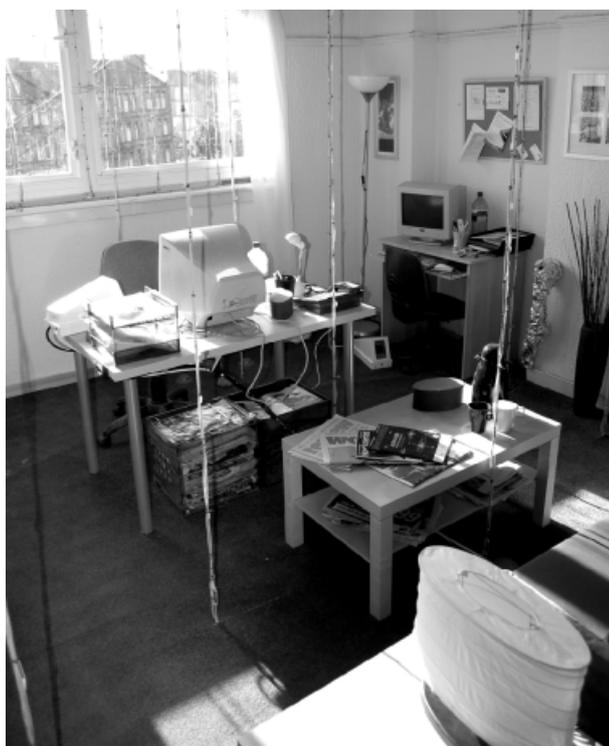
The fire load in the compartment consisted of office furnishing, with the main fire load coming from a sofa placed in the middle of the compartment. Other items of furniture included bookshelves filled with paper, a desk, carpet, a computer and a chair. Figure 5 gives an overview of the compartment furnishings, with the sofa partly visible in the bottom right-hand side of the photograph. The fire was started by the ignition of a waste paper basket next to the sofa. Further details of the fire load can be found in Rein *et al.* (2007).

Figure 5. Photograph of the fire compartment showing the fuel loading (looking north–west)

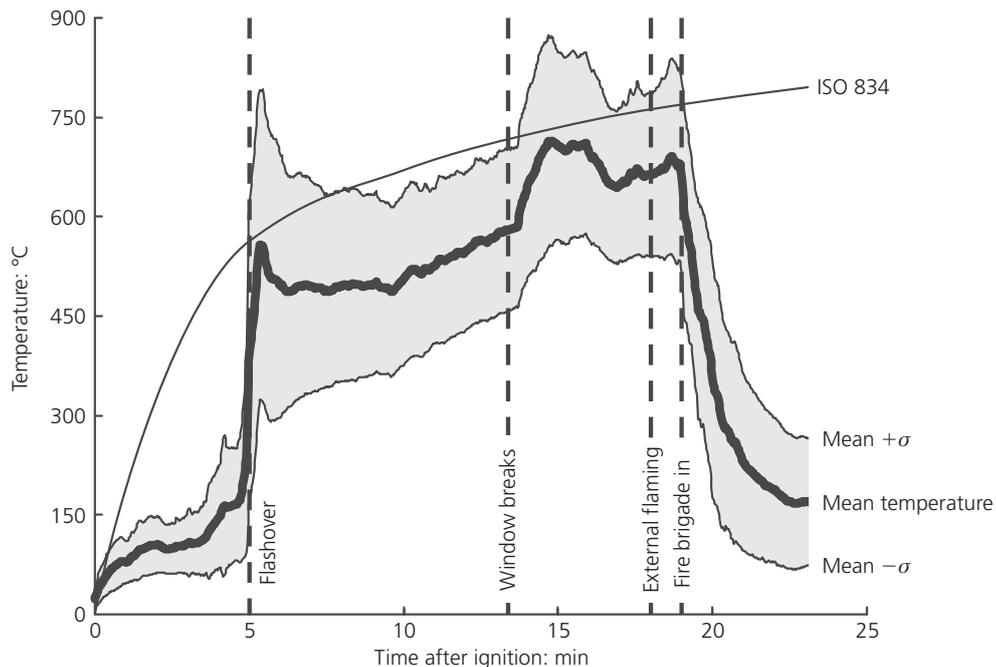
Figure 8 shows the evolution of gas phase temperatures measured within the fire compartment. It plots the mean temperature from 240 thermocouples distributed throughout the volume of the compartment, with the variation in temperature across the compartment indicated by the mean plus/minus one standard deviation curves. The ISO 834 time–temperature curve is included as a benchmark against which the experimental results can be compared. The three main phases of the fire are shown in Figure 8 (corresponding to the events listed in Table 1)

- (a) the growth period, ending with flashover 5 min after ignition
- (b) the fully developed fire, during which the ventilation regime changed at around 13 min when the window was broken, and external flaming beginning at 18 min
- (c) fire extinguished at 19 min by firefighters, after which temperatures decayed.

Figure 8. Gas phase temperatures recorded within the fire compartment (mean ± 1 standard deviation)

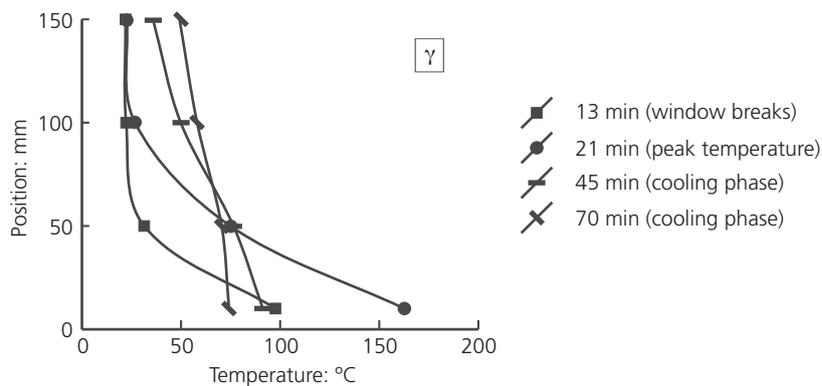
temperature of the lower surface of the slab dropped rapidly at all locations from around 20 min; this is because firefighters sprayed cold water onto the slab while extinguishing the fire. The internal portions of the slab maintained their temperatures despite fire-fighting activities; indeed, the upper layers of the slab continued to increase in temperature even after the fire was completely extinguished. For example, Figure 11 shows the temperature profile through the depth of the slab at location γ .

Figure 11. Temperature variation through the depth of the slab at location γ
