The Condition of the Aberfeldy Footbridge after 20 Years in Service

THE CONDITION OF THE ABERFELDY FOOTBRIDGE AFTER 20 YEARS OF SERVICE

Dr Tim Stratford
School of Engineering, The University of Edinburgh,
The King's Buildings, Edinburgh, EH9 3JL, Scotland
Email: Tim.Stratford@ed.ac.uk

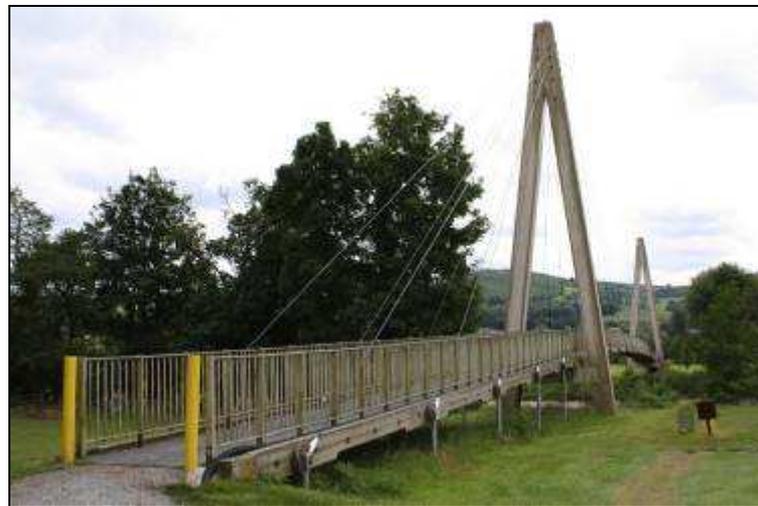
Figure 2. Aberfeldy footbridge from the north (June 2008).

In 2002, the base of the parapet posts were noted to be 'badly scuffed' (Cadei & Stratford, 2002). Figure 17 shows how after another ten years service, the base of some posts are now severely damaged, with substantial loss of section due to impact and abrasion. These posts require repair, and should be protected using a kick board. Separate impact protection has also been added to the northern end of the parapets (Figure 2).

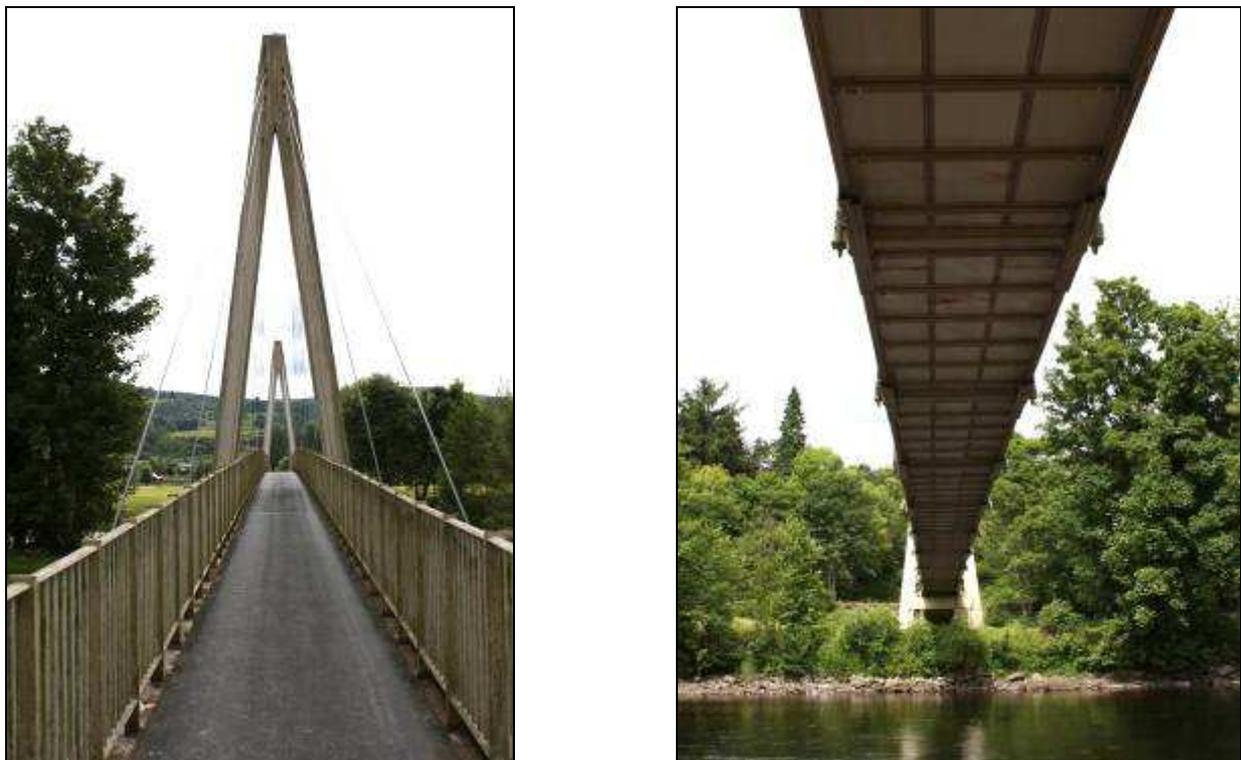
Figure 4. Aberfeldy footbridge from above and below the bridge deck (June 2008)

The parapets consist of rectangular parapet posts, top and bottom rails, and closely spaced circular vertical members (Figure 4). These were all standard GFRP pultrusions, although they were not produced to the same specification as the ACCS deck components. The parapet components consequently exhibit greater erosion of the surface veil, with many regions of exposed fibres, particularly on the bottom rail due to a combination of abrasion and weathering.
