Unbonded post tensioned concrete in fire: A review of data from furnace tests and real fires

Unbonded Post Tensioned Concrete in Fire: A Review of Data from Furnace Tests and Real Fires

John Gales¹, Luke A Bisby² and Martin Gillie³

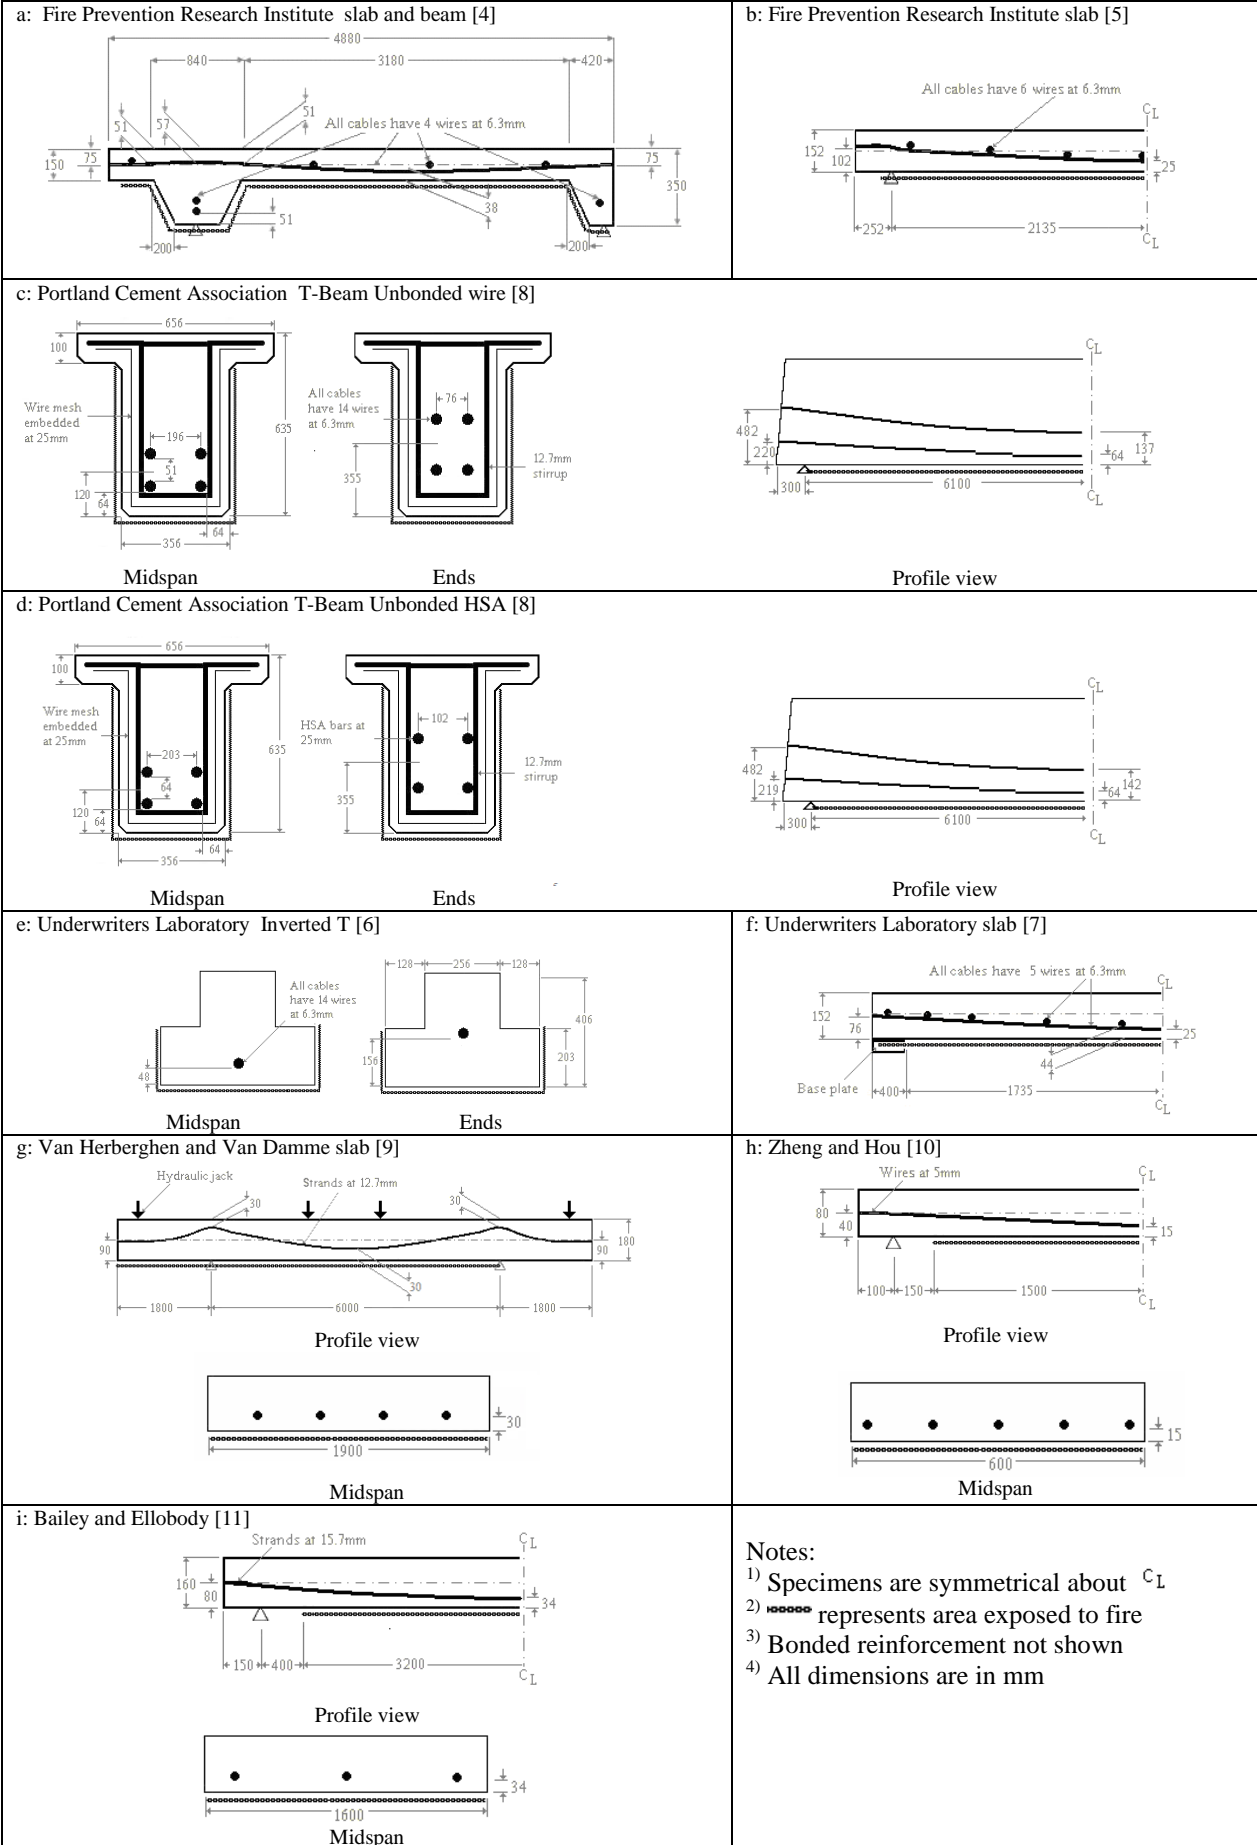
Figure 1: Selected details of furnace test specimens available from the literature

In 1959, FPRI conducted a second fire test of a similar two-way UPT slab panel (without beams). The original testing report is not readily accessible [5], although general descriptions of the test are available elsewhere [40-42]. Figure 1b shows the tested assembly, which consisted of a 152 mm deep siliceous aggregate concrete flat slab panel spanning 3910 mm by 4270 mm and supported on pins at its corners. The slab was prestressed with draped UPT cables in both directions. The minimum clear concrete cover to the UPT cables, each of which consisted of six 6.3 mm diameter wires, was 38 mm in the larger spanning direction at midspan. The tendons were stressed to 990 MPa. No mild steel reinforcement was provided within the spans. The slab was subjected to a uniformly distributed superimposed load corresponding to 1.0 times the design live load and exposed to the E119 [35] fire, again using laterally-restrained conditions in both spanning directions. The RH in the slab at the time of testing was 76% ($\approx 2.3\%$ by mass) at an unknown depth, and the concrete compressive strength was 30 MPa.

In 1964, as part of a larger study on the fire performance of various types of concrete beams, the Fire Research Laboratory of the Portland Cement Association (PCA), Illinois, conducted two standard furnace tests of UPT beams with T-shaped cross sections [8, 41, 42]. The beams' cross-sections are shown in Figures 1c and 1d; they were essentially rectangular, with a depth of 635 mm, a web width of 356 mm, and small flanges of 150 mm \times 100 mm. One beam (Beam 80) was prestressed with four draped UPT high strength alloy bars, each with a diameter of 25 mm and an ultimate strength of 1168 MPa, prestressed to 770 MPa. The other beam (Beam 76) was prestressed with four draped UPT cables, each consisting of fourteen 6.4 mm diameter wires with an ultimate strength of 1760 MPa, prestressed to 1168 MPa. In both cases the minimum clear cover at midspan was 64 mm on both the soffit and the sides.

Details of a typical specimen tested by Van Herberghen and Van Damme [9] are shown in Figure 1g. Also shown is a schematic of the test setup, support and loading conditions, and fire exposure. The eight one-way slab strips were 180 mm thick by 1900 mm wide, and approximately 9000 mm in total length. Longitudinally they all had draped 12.7 mm nominal diameter longitudinal seven-wire prestressing tendons, with 1150 MPa initial prestress levels, and all were continuous over two internal supports with a central span of about 6000 mm and cantilever spans at each end. Only the central span and one cantilever were exposed to fire. Several parameters were varied amongst the specimens:

The slabs were loaded during testing using four hydraulic jacks (as shown in Figure 1g) to produce “a condition of zero rotation at the supports.” Exactly how and why this loading condition was chosen is unclear. As a consequence of this rather unusual support condition, the applied load (and hence the bending moments at the critical sections) varied throughout the tests – it seems unlikely that this was any more representative of full-structure response in a real fire than a restrained standard fire test on an isolated structural element with constant vertical load. The initial load was chosen to simulate a comparatively high uniformly distributed superimposed live load of 4.9 kPa. In the paper describing these tests, Van Herberghen and Van Damme [9] comment that “the importance of the initial bending moments was of minor influence on the ultimate fire resistance.” It is not clear exactly what is meant by this, but it appears from the data presented that the evolution of bending moments during the fire exposure was far more important in governing the slabs’ collapse than the initial loading condition. This is of considerable interest, since the initial load ratio is universally assumed to be of central importance to the structural fire resistance of a flexural assembly in a standard furnace test – to the extent that larger fire endurance are assigned to assemblies with lower load ratios for some types of construction [42, 45]. This confirms the increasingly widespread notion that full-structure interactions in fire are likely to be more significant than the capacities of isolated members as demonstrated through standard furnace tests.

Zheng and Hou [10] report on nine standard furnace tests on small-scale (model), one-way spanning UPT slab strips prestressed with steel wires. Figure 1h provides details of a typical tested assembly. All specimens were fabricated from carbonate aggregate concrete with a width of 600 mm and spanning 3300 mm between simple supports. The prestressing consisted of between two and five prestressing wires, each with a diameter of 5 mm and an ultimate tensile strength of 1722 MPa. The wires were prestressed to between 655 MPa and 1022 MPa prior to testing. A clear concrete cover of 15 mm, 25 mm, or 30 mm to the prestressed reinforcement was provided for the 80, 90, and 95 mm thick slabs, respectively. Varying amounts of mild steel longitudinal reinforcement were provided within each of the slabs; the mild steel longitudinal reinforcement ratio varied between 0.20% and 0.45%. All slabs had mild steel transverse reinforcement with the same clear cover as the prestressed reinforcement at midspan, and with a reinforcement ratio of about 0.17% to 0.20% depending on their thickness.

Bailey and Ellobody [3, 11, 46] report the results of four large-scale furnace tests on one-way spanning UPT concrete floor slabs in which the lateral (longitudinal) restraint condition (“free” or “restrained”) and the type of aggregate (limestone or Thames gravel) were varied. Different aggregates were apparently used to investigate the effect of different amounts of thermal expansion on the structural behaviour, and perhaps also to study spalling. Details of the specimens are given in Figure 1i. The slabs were 1600 mm wide and 160 mm deep, and spanned 4000 mm between simple supports. Each slab had three longitudinal seven-wire prestressing tendons, each with a nominal cross-sectional area of 150 mm² and an ultimate tensile strength of 1846 MPa. The tendons were prestressed to about 1120 MPa after losses. The minimum concrete cover to the centroid of the draped prestressing tendons was 42 mm at midspan. This corresponds to a clear cover of approximately 34 mm. No mild steel reinforcement was provided within the tested spans.
