## The Dalmarnock Fire Tests on a Cast Insitu Concrete Structure

## TG 4.3 *fib* 2007 THE DALMARNOCK FIRE TESTS ON A CAST INSITU CONCRETE STRUCTURE

In July of 2006 three full scale fire tests were undertaken on a 23 storey cast in situ concrete structure. This paper provides an overview of the experimental set up of Test One which involved a fully developed post flashover fire in a 17m<sup>2</sup> compartment. Full scale fire tests on concrete structures are in-frequent and complete data sets rare. This experiment provides a complete data set for both the fire behaviour and the structural response in both the heating and cooling phases of the fire. The fire behaviour and subsequent structural response are examined and explained.

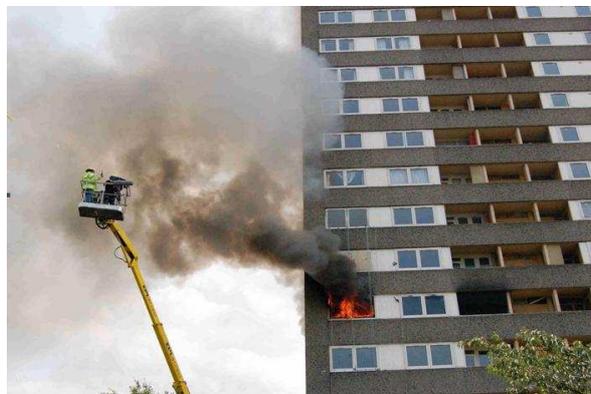
Figure 1: Dalmarnock fire test one seen from outside 18.5 min into the fire

Test One, took place on the fourth floor of a 23 storey cast in situ concrete structure as can be seen in fig 1. Figure 2 shows the layout of the flat in which Test One was conducted. The experimental compartment was the living room of the flat. It was approximately 17 m<sup>2</sup> in plan containing two door ways, one led to the flat corridor and the second to the kitchen, it also contained a set of windows in the west facing wall. The north and west walls of the compartment were external. The south and east internal walls segregated the experimental compartment from bedroom one and the kitchen respectively.

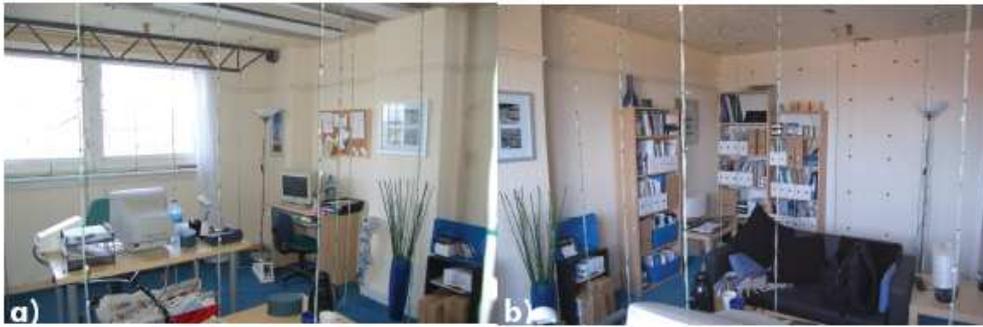
All furniture and fittings were removed from the flat (with the exception of embedded units in the kitchen). The room was furnished as a typical living room/home office. Figure 3 indicates the general fuel layout. The main sources of fuel were three book shelves in the north east corner of the compartment, loaded with books, magazines and plastics. Just in front of the sofa was a polyurethane sofa. Some computers, desks and chairs were located towards the front of the compartment.

Figure 3: Fuel distribution in compartment fire test
